Systematic Analysis of Gear Failures

Lester E. Alban

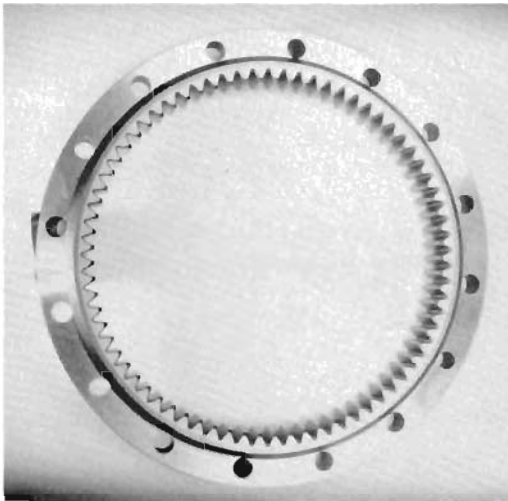
Fig. 1-3. Internal gear and pinion. This set can be either spur or helical.

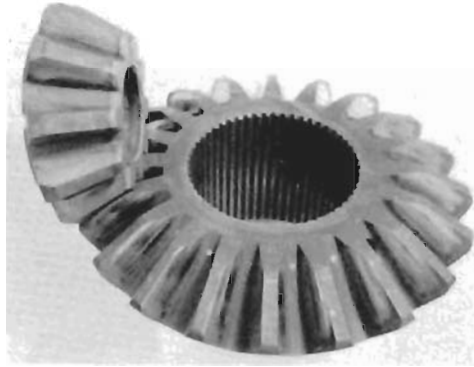
Fig. 1-4. Straight bevel gear and pinion.

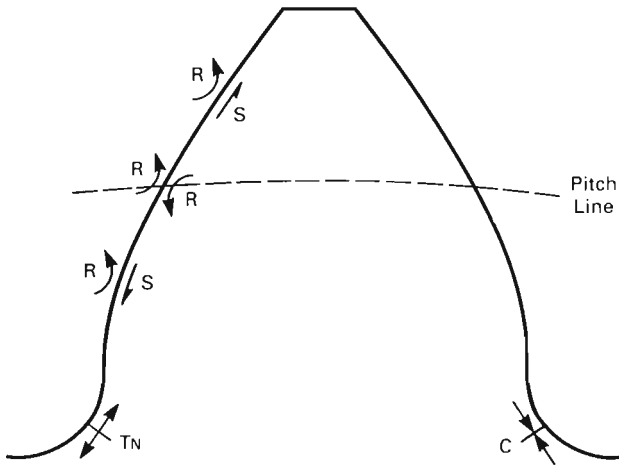
Fig. 1-9. Diagrammatic stress areas on basic spur gear tooth.

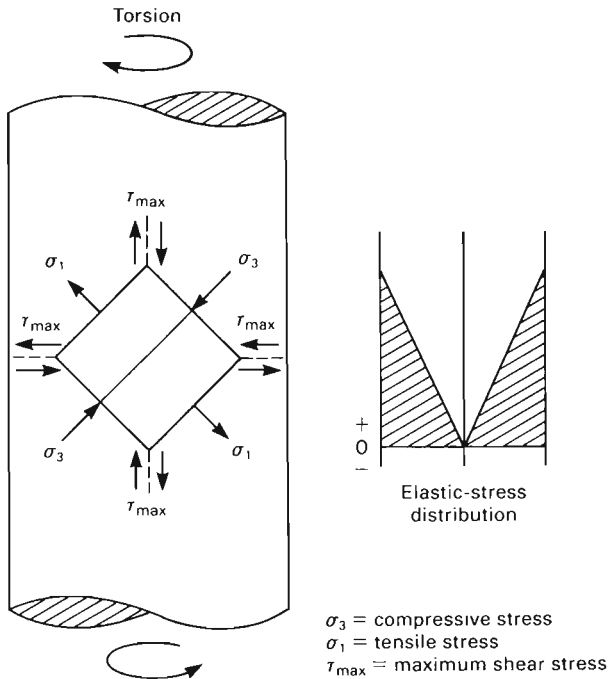
Fig. 1-11. Free-body diagram of maximum tensile and shear stress orientation on a surface element of a shaft in a torsional mode. Both maximums are at the surface. Stress is considered to be zero at the central axis.⁴

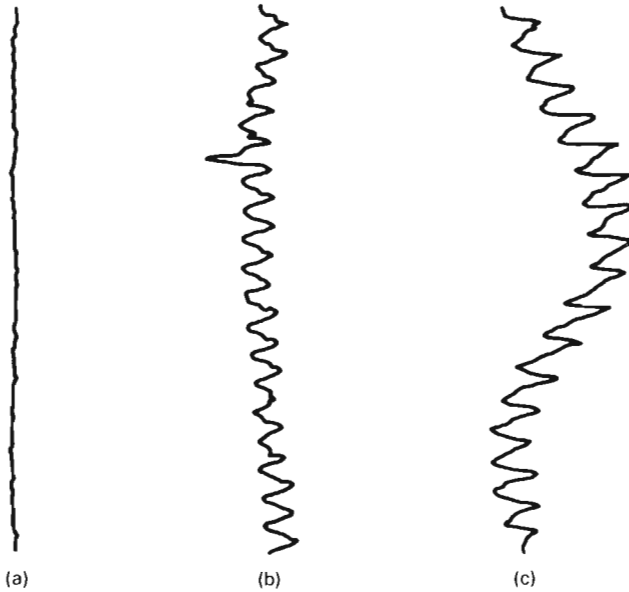
[a] Ideal straight line, no runout; very little tooth-to-tooth jump, due to helical tooth overlap. [b] Almost straight line, 0.001-in. overall runout; perceptible tooth-to-tooth jump, typical of spur gearing. Note the one protuberance due to surface nick. [c] Spur gear with 0.006-in. overall runout.

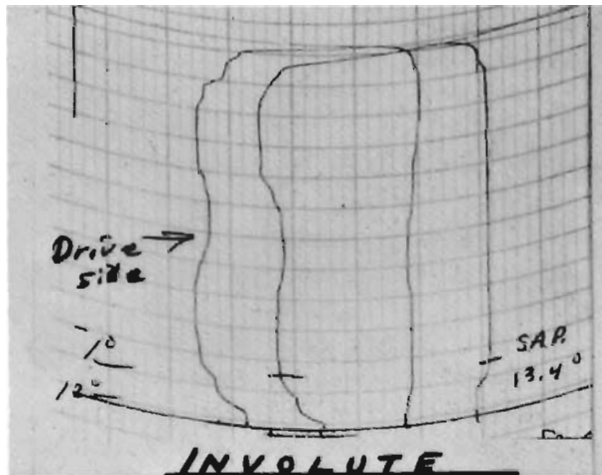
Fig. 1-14. Charted involute pattern of two teeth (180° apart) from a gear in service. Unused profile has an excellent involute; the loaded profile shows pitchline and tip wear.

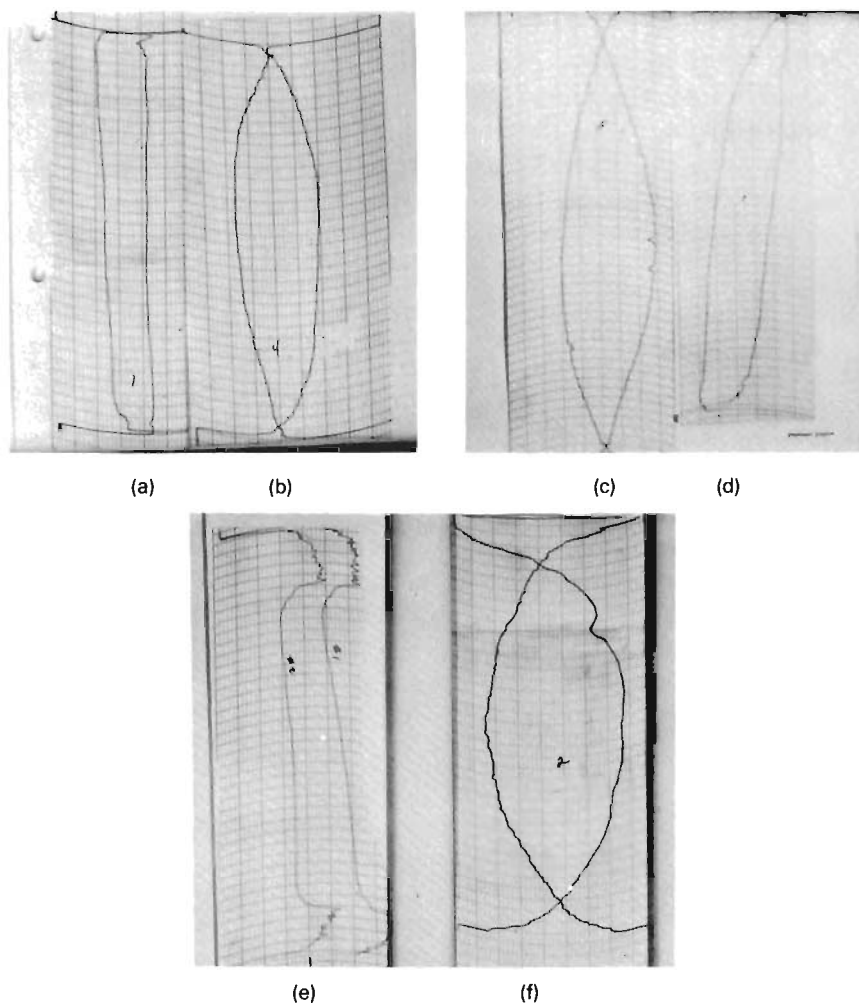
(a) True lead along both profiles. (b) True lead, tooth crowned 0.0015 in. per side. (c) True lead with crown. Indicator shows pitting along the pitchline. (d) A crowned tooth with considerable lead error, shifting the crown toward opposite ends of each profile. (e) Lead pattern of loaded side of two random teeth of same gear; result due to abrasive wear. (f) True lead, tooth crowned 0.006 in. per side, which seems abnormally high.

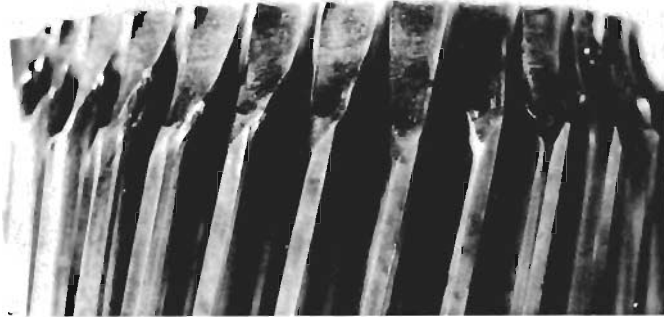
Fig. 1-16. Helical gear. All tooth characteristics were "perfect." Field failure had been matched with pinion showing lead pattern of Fig. 1-15(d).

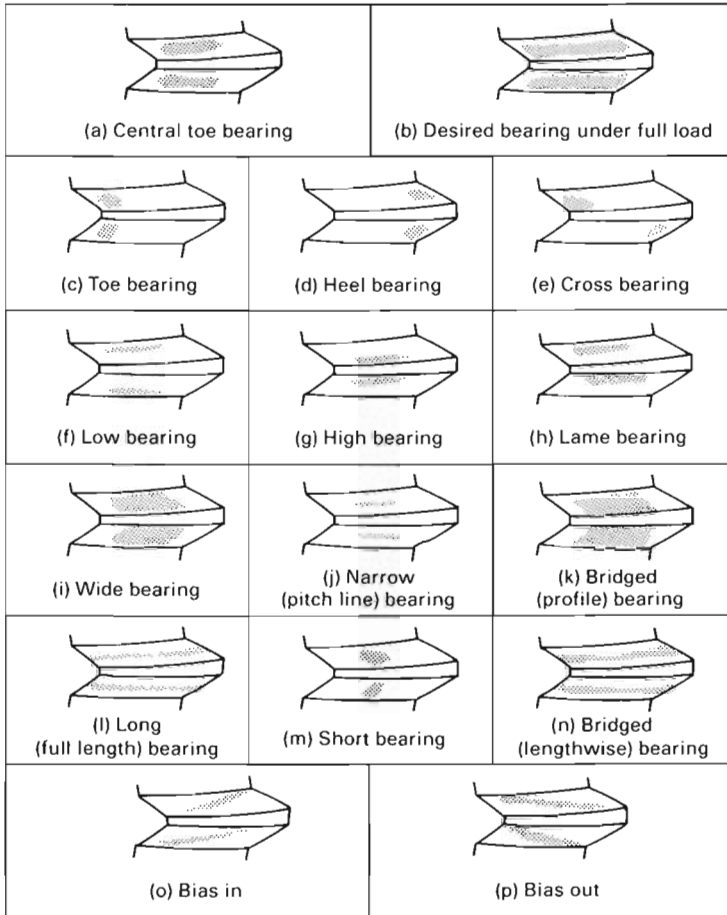
Sketches illustrate tooth bearings on the pinion tooth. Although a left-hand pinion is used throughout, the bearings are representative of those on a right-hand pinion or a straight bevel pinion as well.

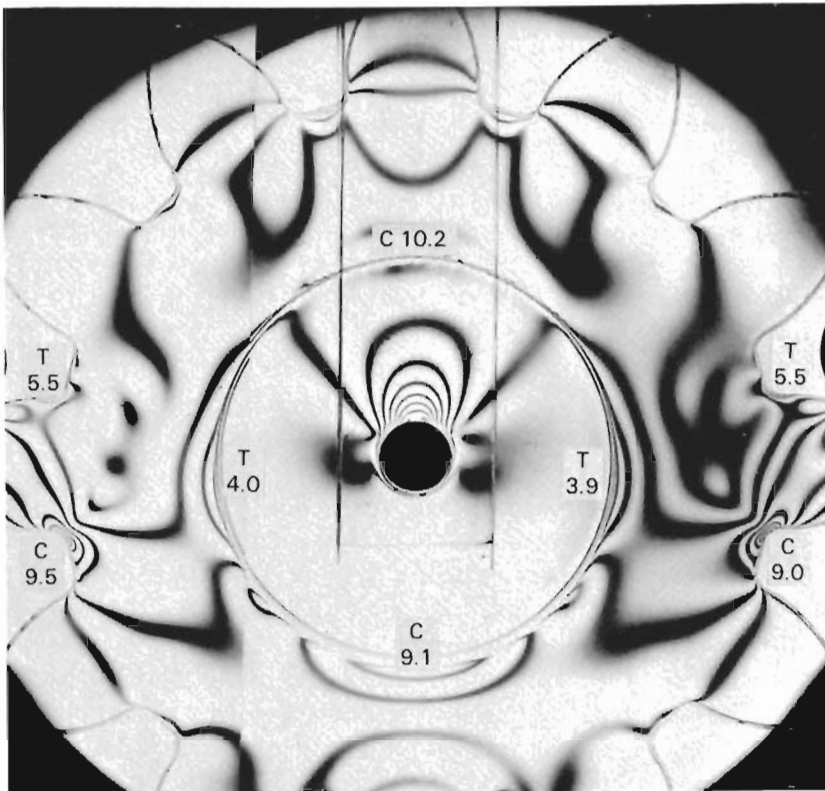
Fig. 1-20. Photoelastic pattern of idler gear between load input pinion and load output gear.

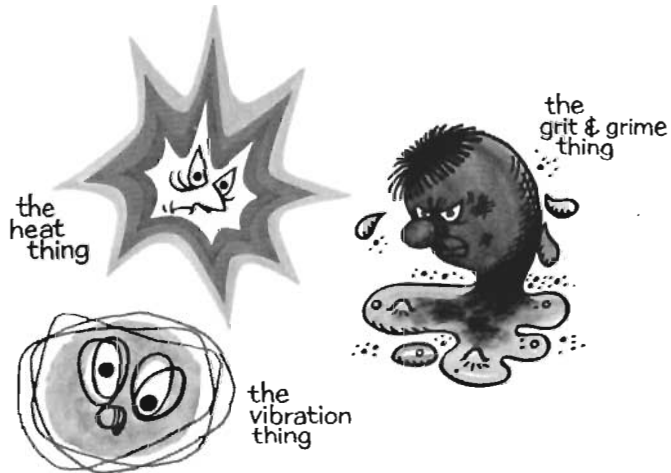
Fig. 2-1. Environmental factors consist of mostly “things”: lubrication, temperature, and mechanical stability.

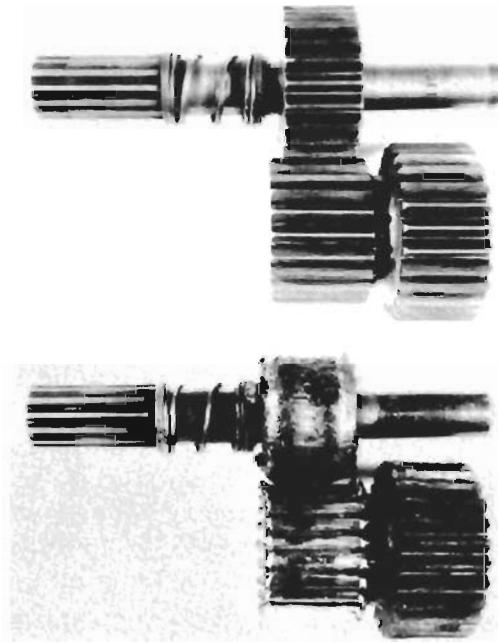
Fig. 2-2. Comparison of gear sets showing that lack of lubrication can be most devastating.

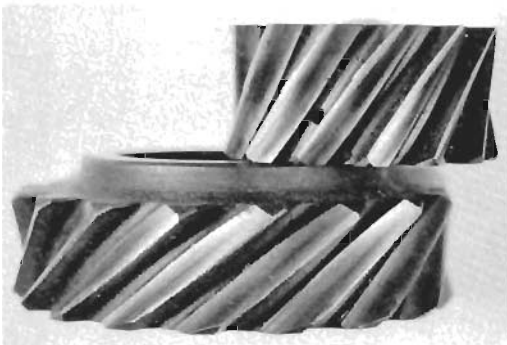
Fig. 2-3. Abrasive wear progresses rapidly and uniformly when an abrasive contaminant saturates the lubricant.

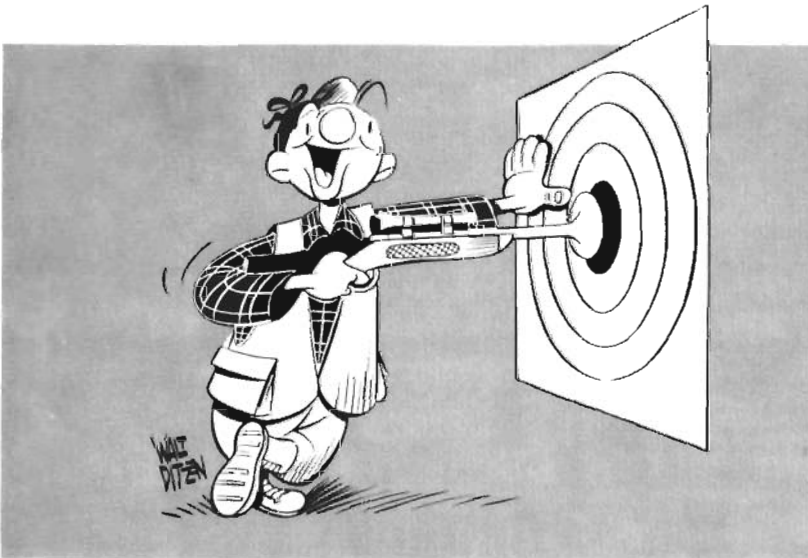
Fig. 2-5. Perfect alignment is necessary for accurate results.

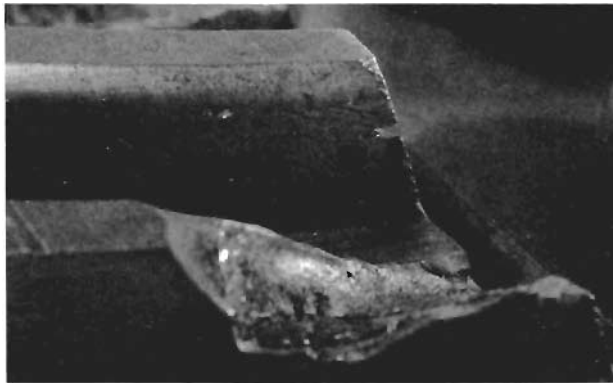
Fig. 3-1. Spiral bevel gear, 2.5 D.P. SAE4820H, case depth 0.068 in., 58 HRC. Operation: coal mining. Every tooth crushed and subsequently broken at toe end, midprofile, convex (loaded) side.

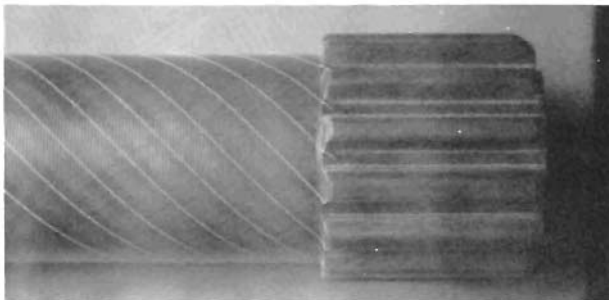
Fig. 3-2. Unidirectional torsion overload in a 1-in.-diam jack shaft, as revealed by magnetic-particle inspection by "Magna-Glo" method. Photographed using a standard "black" light and Polaroid Polacolor-2 Type 58, 4×5 Land film, ASA75, *f*/11, for one minute.

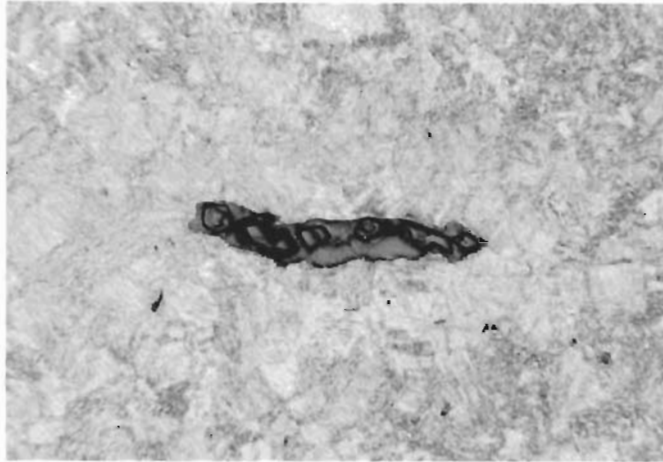
Fig. 3-3(a). A massive flat inclusion parallel to the top face of a spur gear tooth at a distance of 0.228 in. from the surface. This inclusion gave a sharp sonic indication for a distance of 1/2 in. along the tooth length. 3% nital etch, 200 \times .

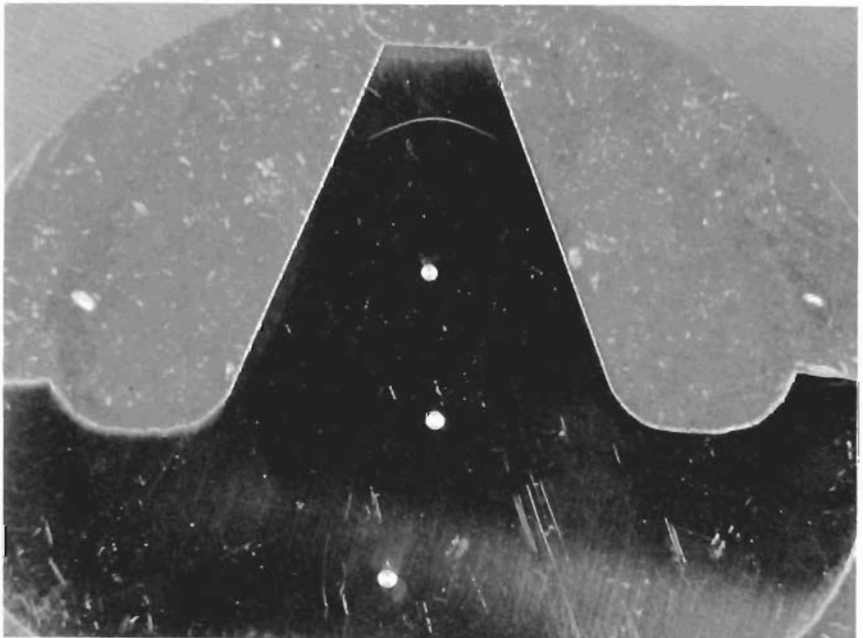
Fig. 3-3(b). An internal rupture in a gear tooth at the case/core transition zone which does not reach the surface. This condition can be discovered by ultrasonic testing.

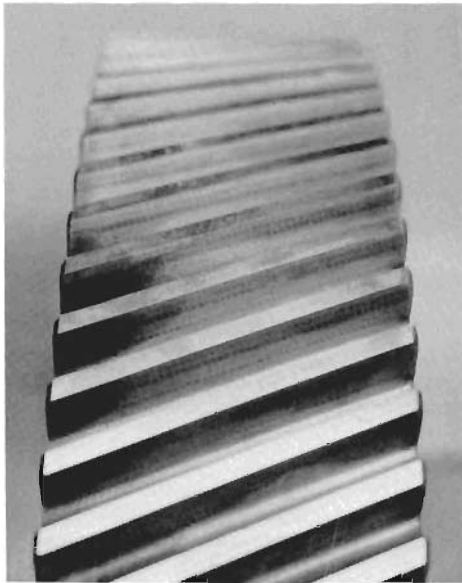
Fig. 3-4. Helical gear carburized and hardened to 60-63 HRC. A chattering tooth grinding wheel has “burned” small consecutive spots the full length of the profile on several teeth. Discovered by nital etching.

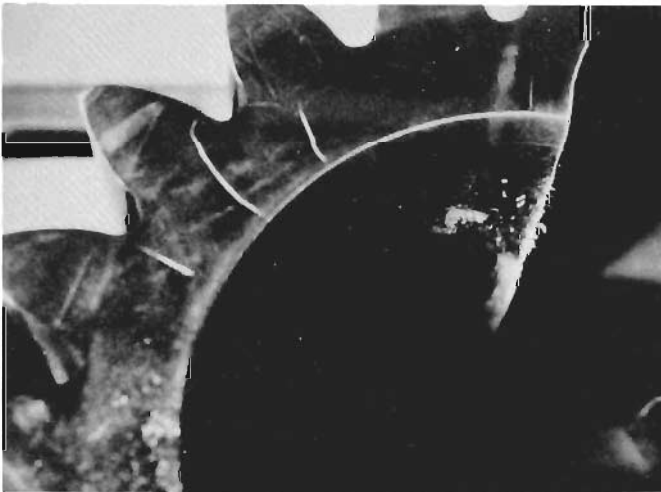
Fig. 3-5. Spur gear, end face ground. Grinding severity tempered the entire face (revealed by nital etching) and checked the surface (revealed by magnetic-particle inspection).

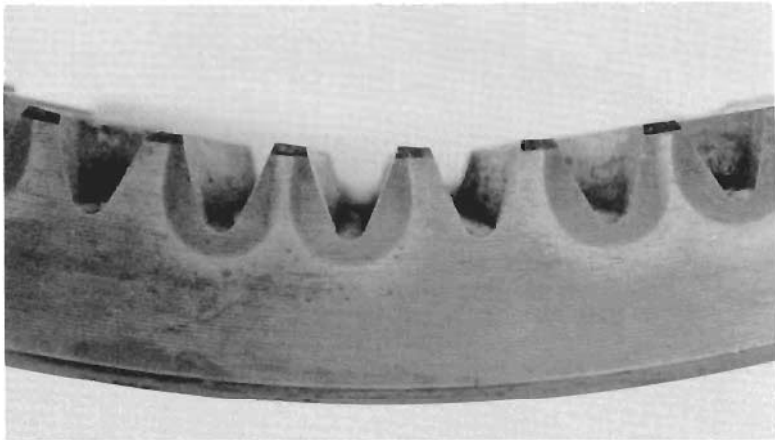
Fig. 3-7. End face nital-etched pattern of an induction hardened internal gear, showing two tooth spaces that had not been hardened.

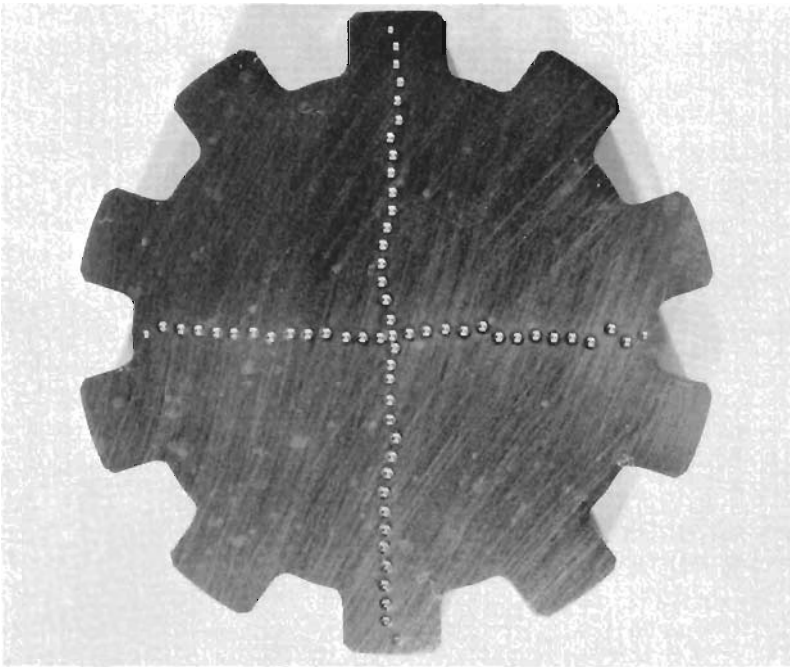
Fig. 3-8. Cross-sectional hardness survey through the splined section of a spiral bevel pinion shank. First readings at the surface [O.D. of the sample]. Continuous readings at 1/16-in. intervals starting 1/16 in. from the surface.

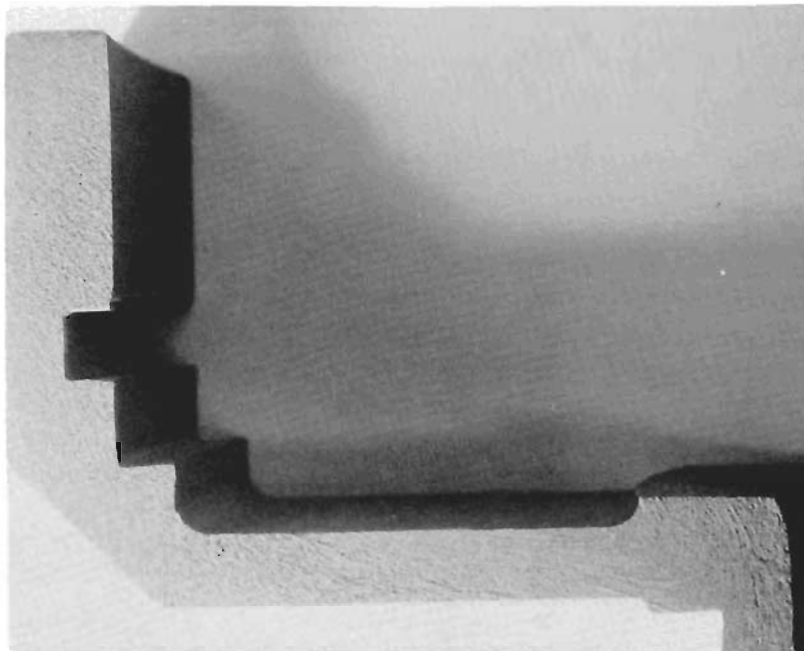
Fig. 3-10. Internal gear blank, 1/4×. Macroetched to show material flow lines after forging and machining.

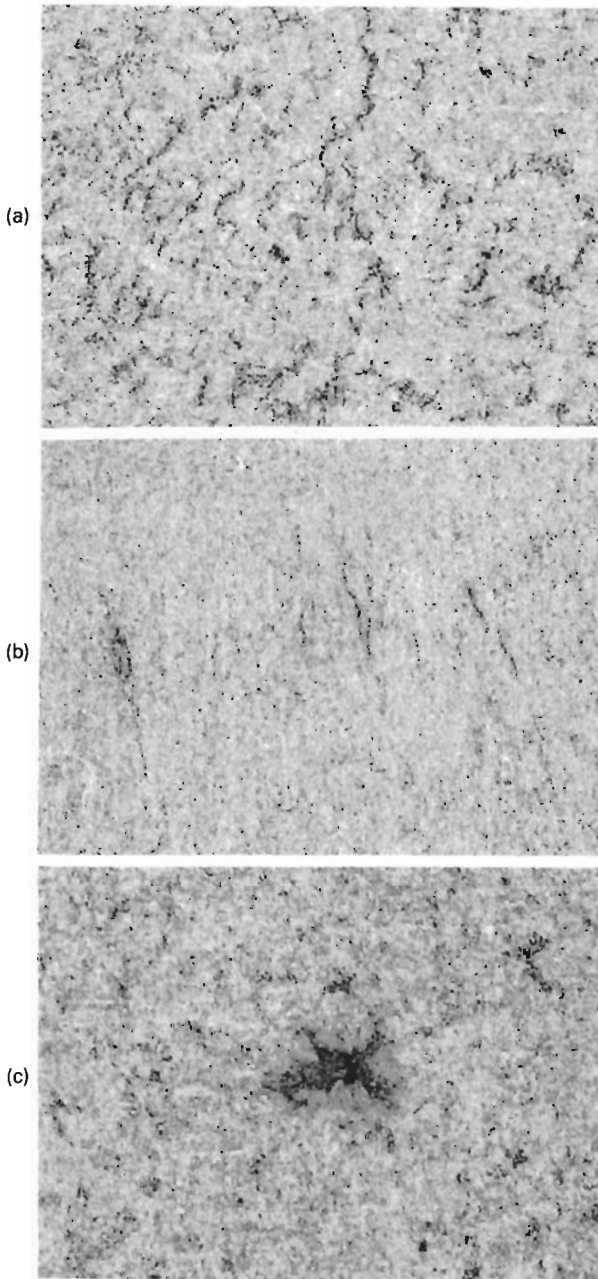
Fig. 3-16. Macrostructure, 100X. Macroetched to show center soundness of a steel part: (a) fairly sound, small pinholes; (b) slight porosity; (c) open pipe.

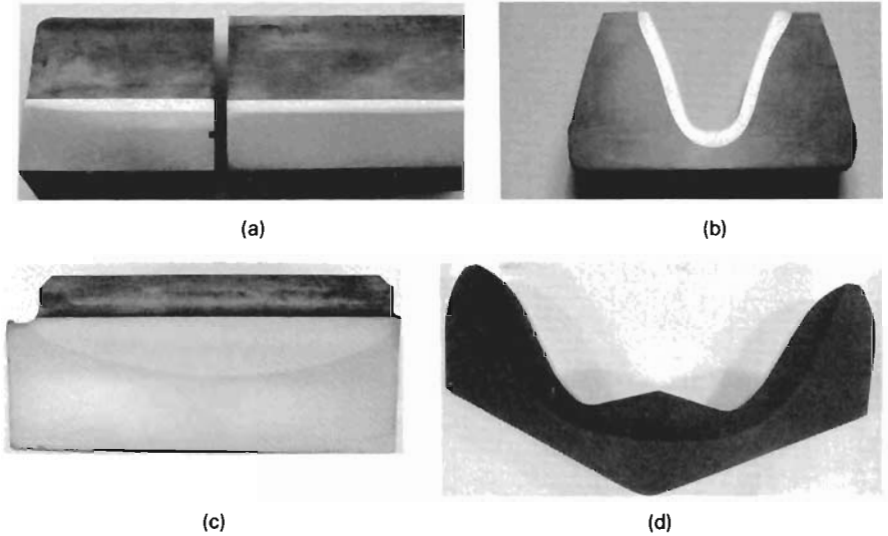
(a) 1/2X. Longitudinal section through tooth root. Hardened by traversing one tooth space at a time. (b) 1/2X. Cross section of tooth space near center of same tooth as in [a]. (c) 2X. Longitudinal pattern includes entire tooth and well below the roots. Entire gear hardened at once by a circular inductor. (d) 1/2X. Sprocket tooth space hardened by a stationary tooth space inductor.

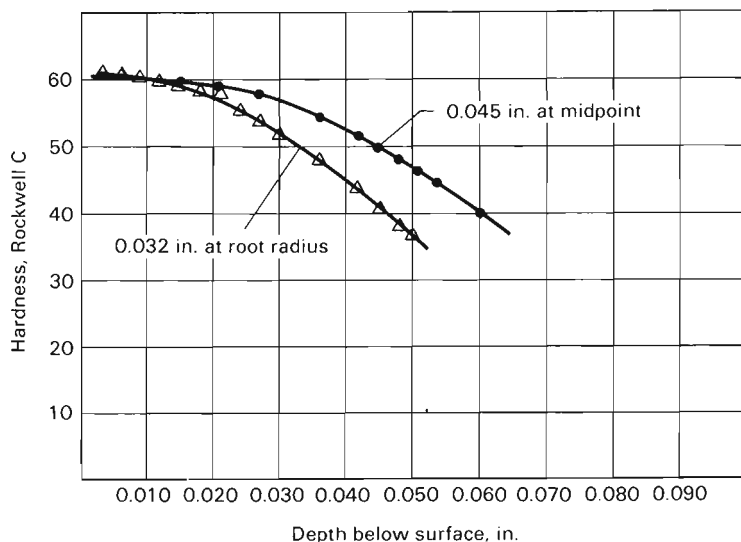
Fig. 3-20. Case hardness traverse of an 8620H steel spur gear tooth using a Tukon microhardness tester with an indenter load of 500 g. Effective case depths are indicated by arrows.

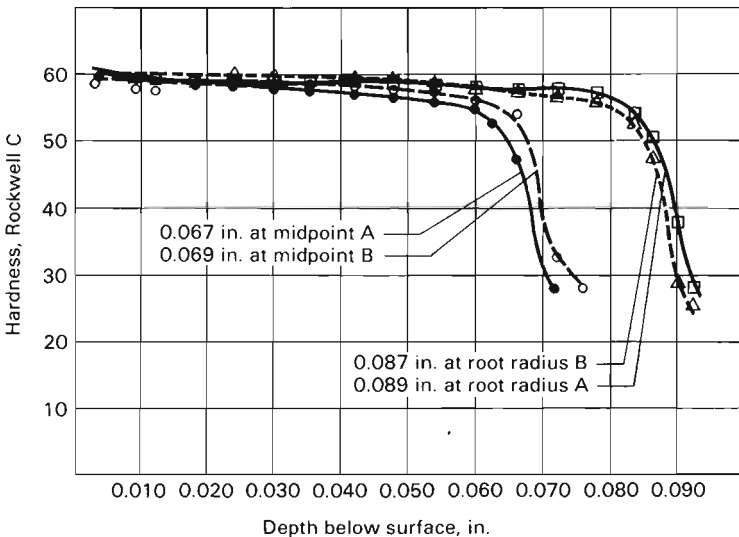
Fig. 3-22. Case hardness traverse of an induction hardened 4145H steel gear tooth using a Tukon microhardness tester with an indenter load of 500 g. Effective case depth is measured to 45 HRC as indicated by arrows.

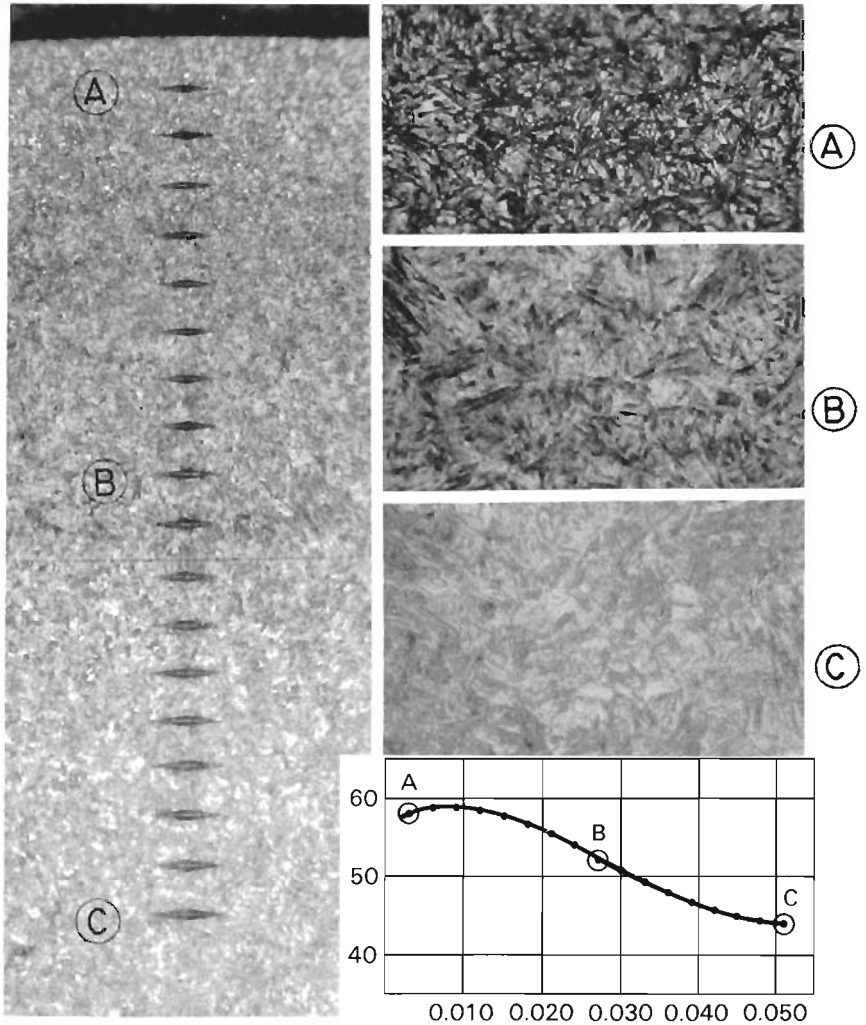
Fig. 3-23. Case hardness traverse with Tukon 500 g at 0.003-in. interval (100 \times) charted to show Rockwell "C" hardness at each distance from surface. Material is SAE 4320H, carburized at 1700 $^{\circ}$ F, diffused at 1550 $^{\circ}$ F, direct quenched in oil at 300 $^{\circ}$ F, and tempered at 350 $^{\circ}$ F. Microstructure, 500 \times . 3% nital etch. (A) Tempered acicular martensite retaining approximately 15% austenite, 58 HRC; (B) Medium-carbon (0.40% C) martensite, 52 HRC; (C) Low-carbon (0.21% C) martensite, 44 HRC.

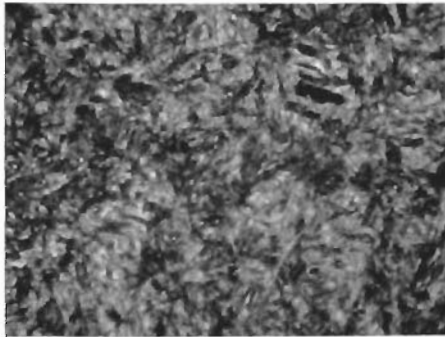
Fig. 3-24. Microstructure, 500 \times . 3% nital etch. Dense tempered martensite (0.75% carbon). Carburized SAE 4320H. Retained austenite, nil.

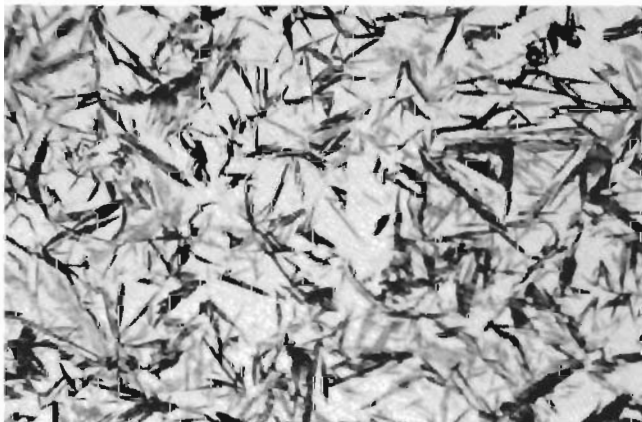
Fig. 3-25. Microstructure, 500 \times . 3% nital etch. Tempered acicular martensite in matrix of austenite (45%). Carburized SAE 4620H at 0.95% C.

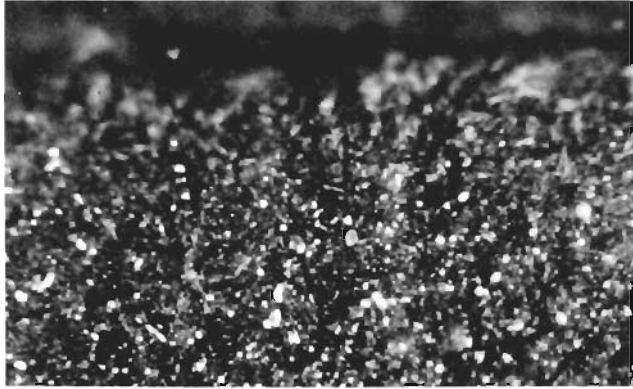
Fig. 3-26. Microstructure, 500 \times . 3% nital etch. Fine spheroidal carbides scattered throughout a tempered martensitic case.

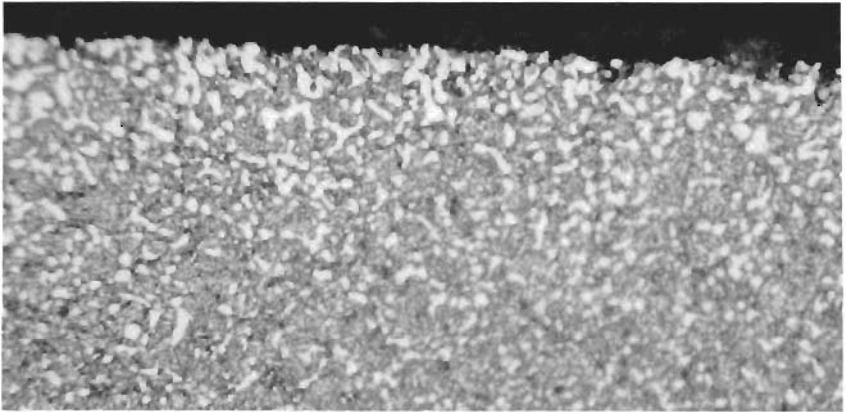
Fig. 3-27. Microstructure, 200 \times . 3% nital etch. Massive globular carbides in matrix of tempered martensite.

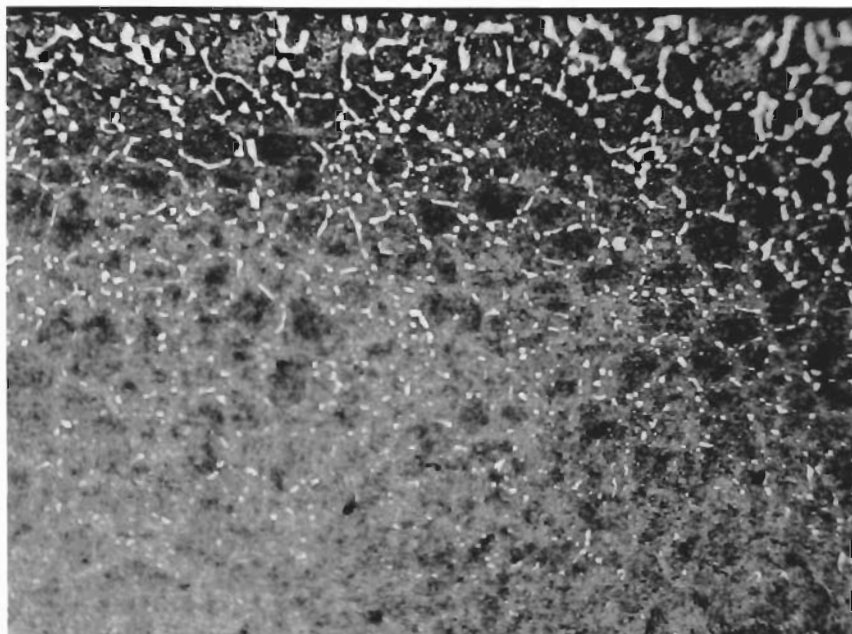
Fig. 3-28. Microstructure, 200 \times . 3% nital etch. Massive carbides in network around grain boundaries. Matrix of tempered martensite and bainite.

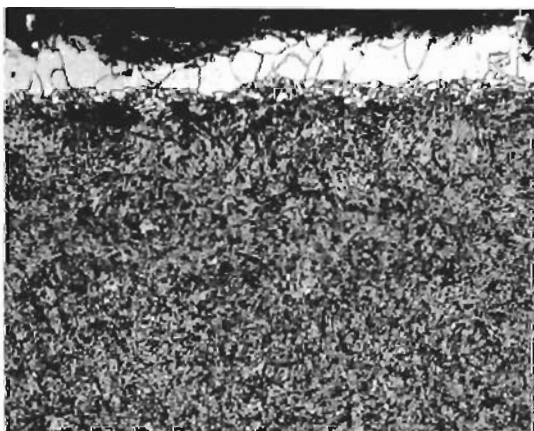
Fig. 3-29. Microstructure, 250 \times . 4% nital etch. Gross decarburization of carburized SAE 4118 steel above matrix of tempered martensite.

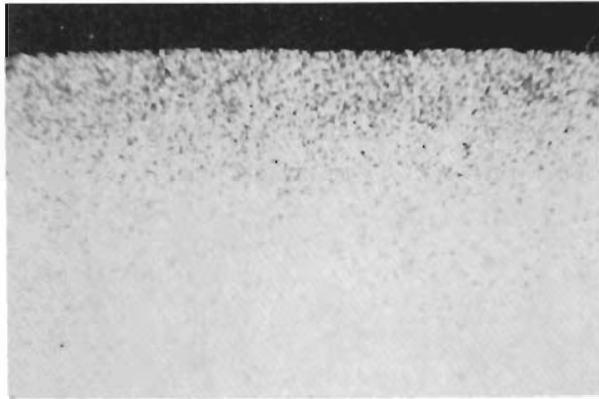
Fig. 3-30. Microstructure, 100 \times . Picral etch. Scattered bainite (dark spots) along surface of a tempered martensitic case.

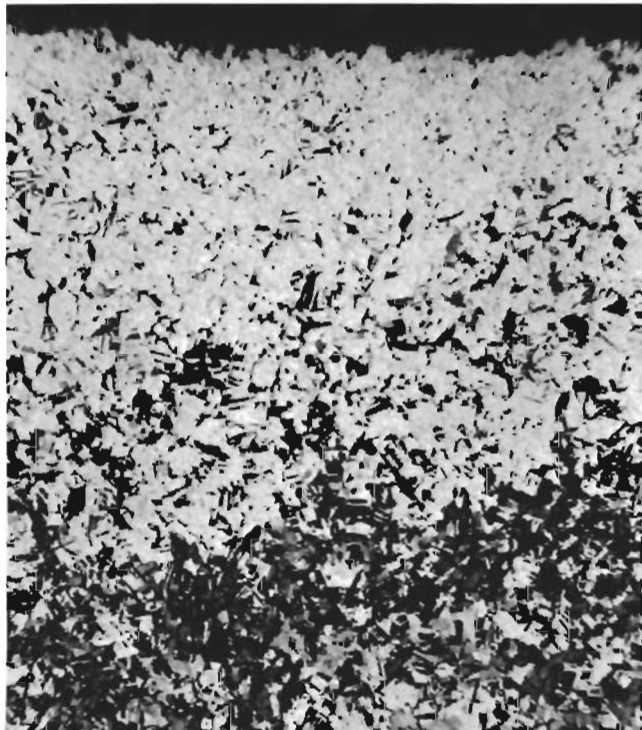
Fig. 3-31. Microstructure, 100 \times . 3% nital etch. Bainite (dark structure) extending from the case/core transition through the tempered martensitic case to the surface.

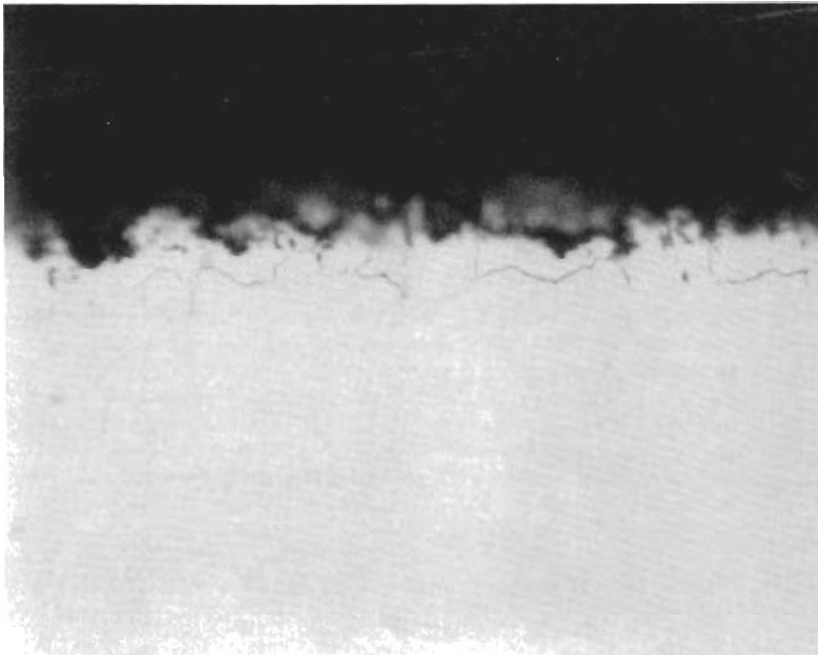
Fig. 3-32. Microstructure, 500 \times . As polished. Black grain oxide network extending into the case from the surface to approximately 0.0004 in.

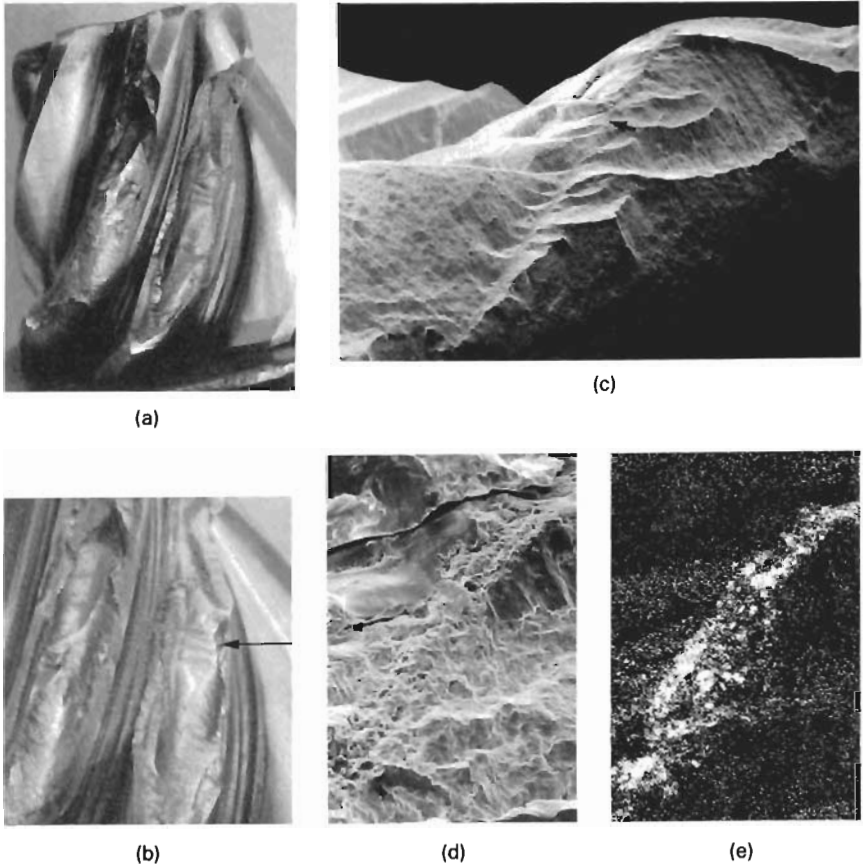
Fig. 3-33. (a) Spiral bevel pinion showing tooth spalling of two adjacent teeth; 1.7 \times . (b) Spalling fatigue originating subsurface, nucleated by a nonmetallic inclusion (arrow); 2.5 \times . (c) Scanning electron micrograph of the fatigue origin at the inclusion (arrow); 27 \times . (d) SEM closeup of the central area of the inclusion; 237 \times . (e) SEM qualitative analytical picture of the amount of aluminum within the inclusion and the surrounding area.

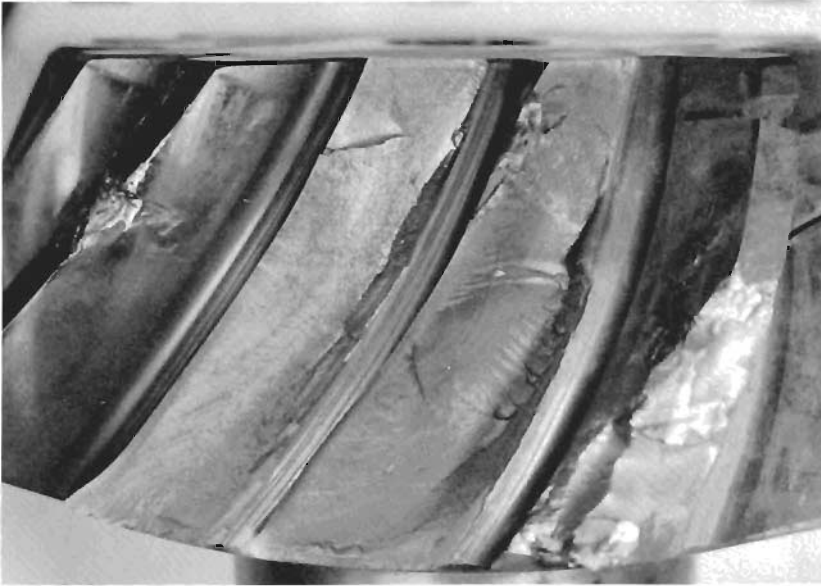
Fig. 4-1. Spiral bevel pinion showing classic tooth bending fatigue with origin at midlength of the root radius on the concave (loaded) side. 0.6 \times .

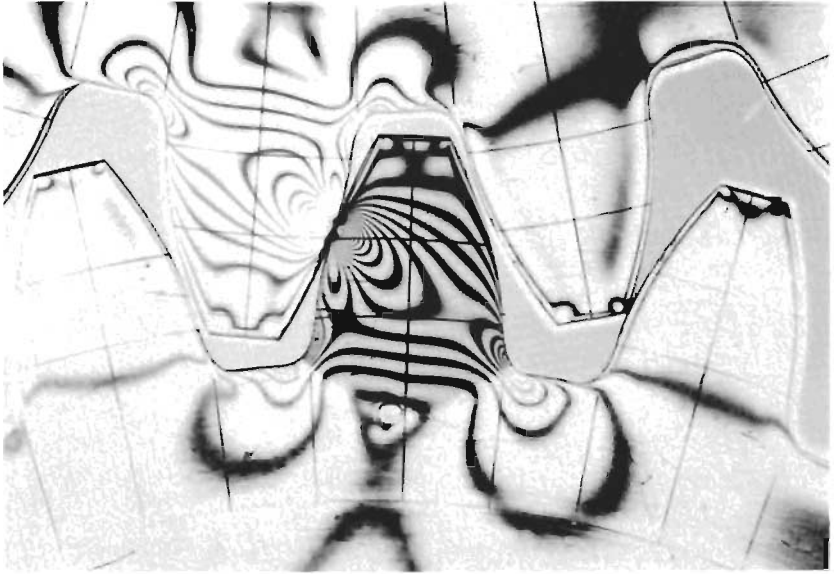
Fig. 4-2. Photoelastic study of two mating pinion teeth receiving full load. Note the high concentration of compressive stress at the point of contact, the tensile stress at the root radius, and the zero-stress point at the tooth centerline below the root circle.

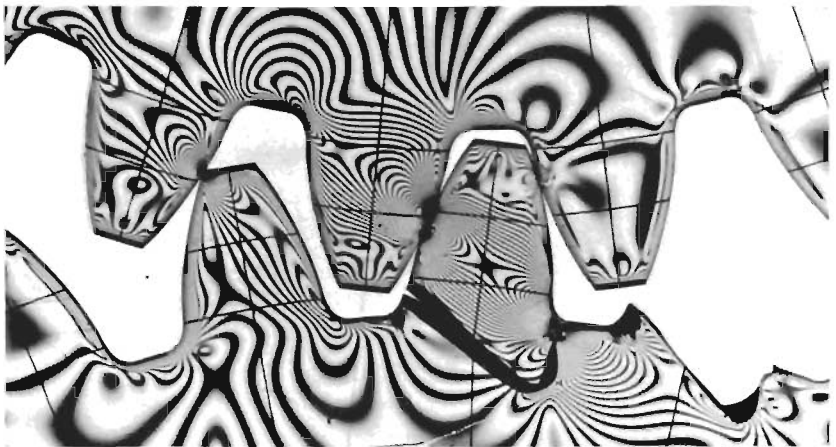
Fig. 4-3. Photoelastic study of mating teeth indicates the shift of the zero-stress point during crack propagation until final fracture reaches the opposite root radius. At the same time, deflection of the tooth allowed the adjacent tooth to pick up the load.

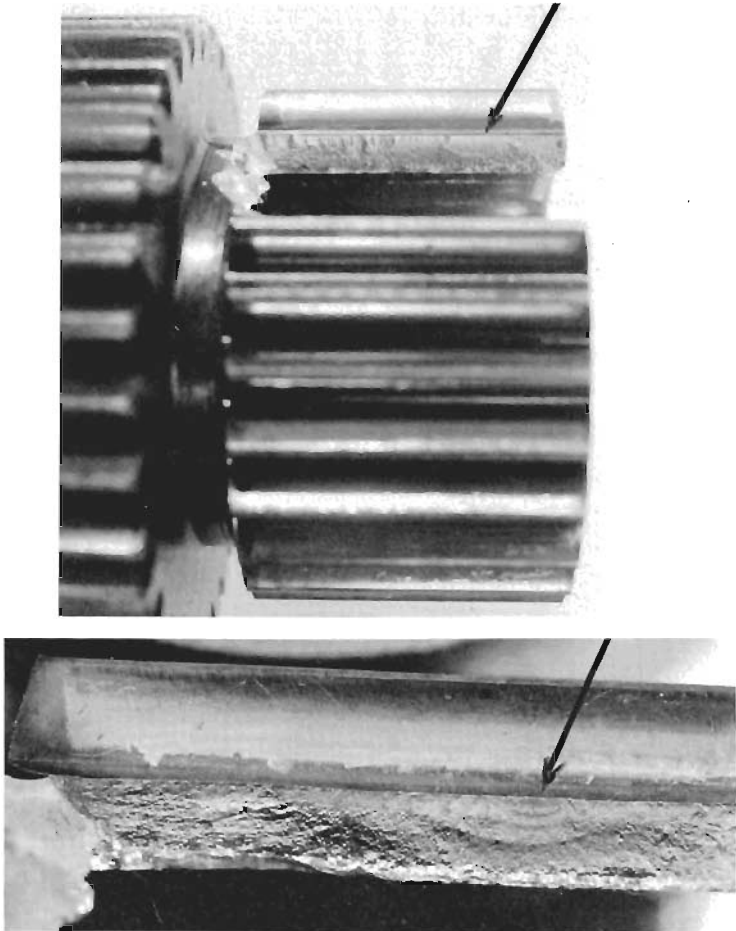
Fig. 4-4. Spur tooth pinion at 1× (top) and 2.5× (bottom). Tooth bending fatigue originating at the root radius (arrows), loaded side, one-third the distance from the open end. Progression was to the bore.

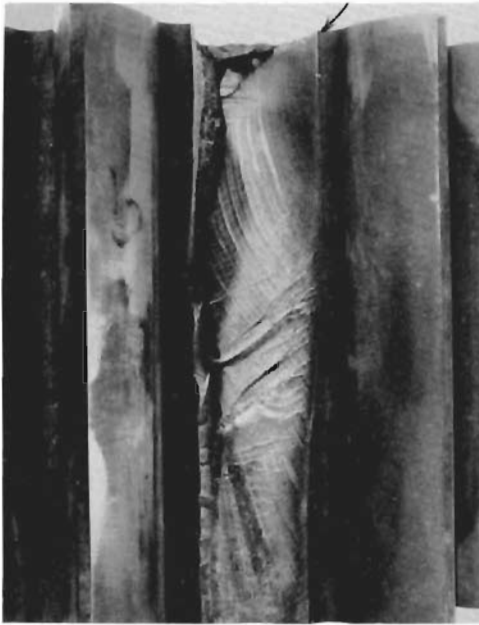
Fig. 4-5. Spur pinion, 7/8 \times . Tooth bending fatigue with origin at root radius of loaded side at one end of the tooth.

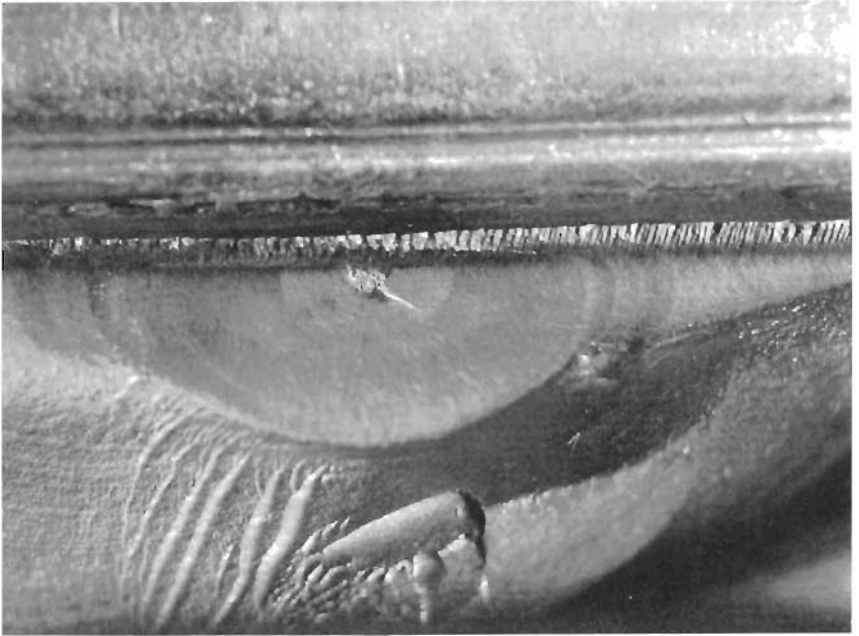
Fig. 4-7. Spur pinion, 100 \times . Tooth bending fatigue at mid-length of tooth at root radius, but origin is at an inclusion located in the case/core transition.

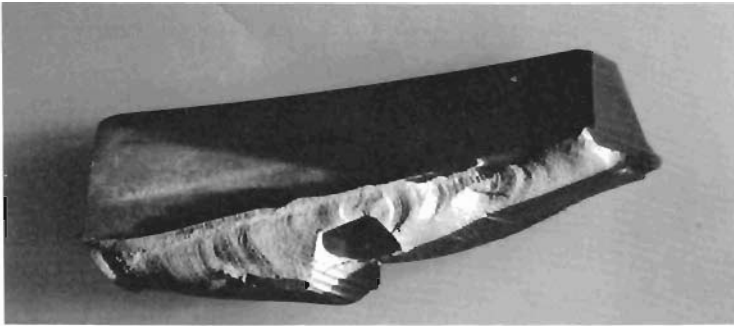
Fig. 4-8. Spiral bevel gear tooth, 0.7 \times . Tooth bending fatigue with origin at the apex of the drilled bolt hole, which terminated just below the root radius.

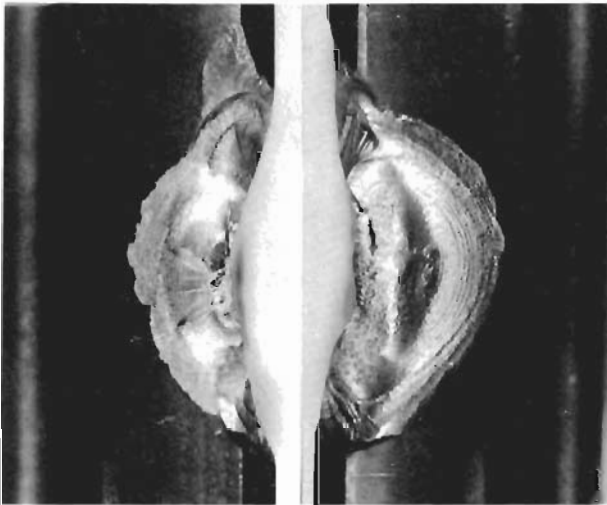
Fig. 4-9. Spur pinion tooth, 2 \times . Bidirectional tooth bending fatigue, with applied loads at a high spot at the top edge on both sides. Origin is at the case/core interface, near the crown of the tooth.

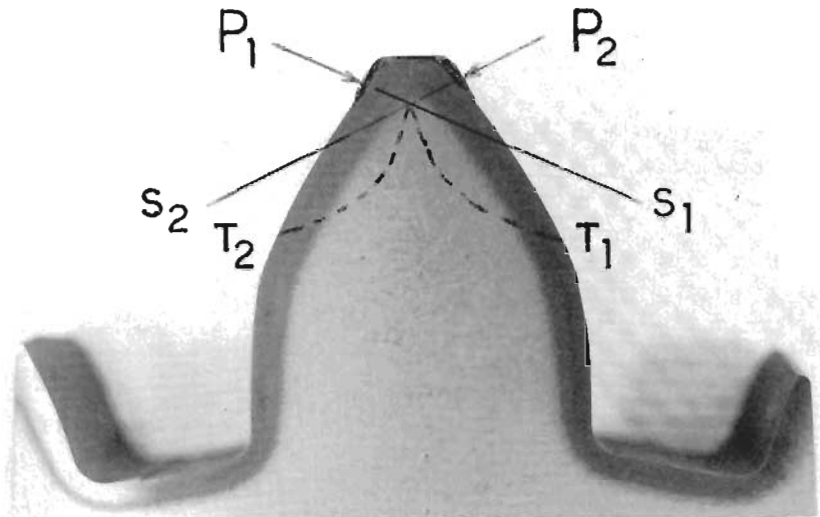
Fig. 4-10. Sketch of forces, shear and tensile stress planes, and directions present in the failure depicted in Fig. 4-9.

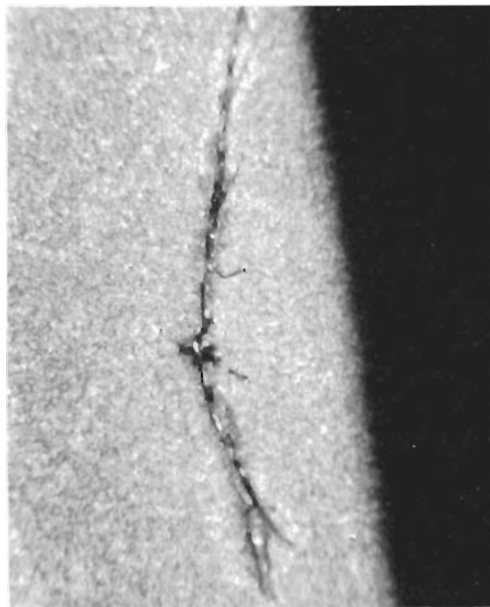
Fig. 4-11. Spur gear tooth, 100 \times . Nital etch. An internal crack originating at an oxide type of inclusion below the surface at the pitchline. A pit is being formed.

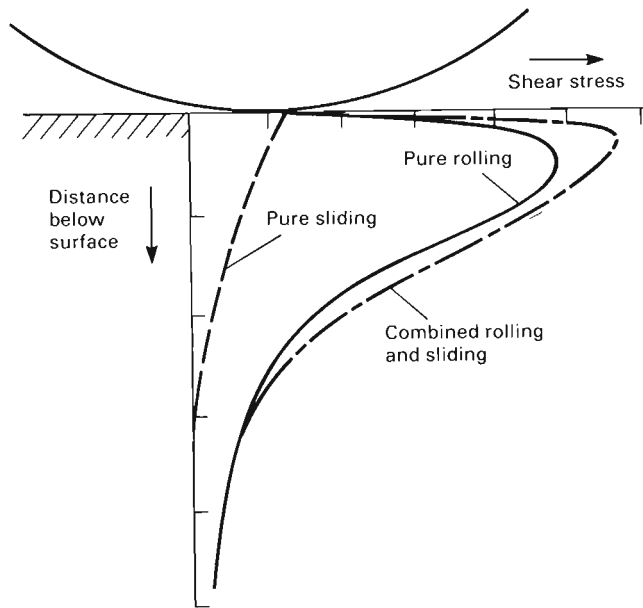
Fig. 4-12. Stress distribution in contacting surfaces due to rolling, sliding, and combined effect.

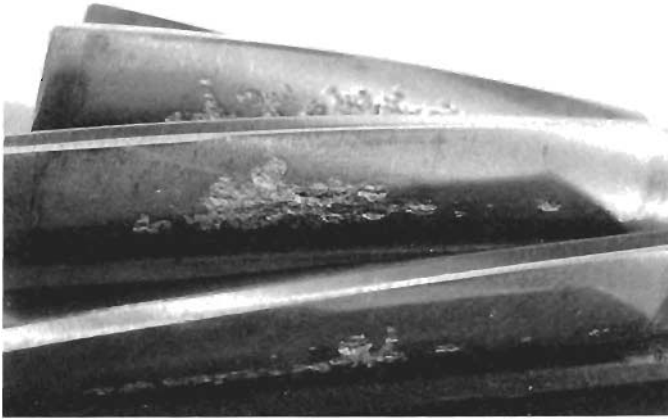
Fig. 4-13. Helical gear teeth, 2X. Pitting initiated along the pitchline and just above the pitchline. In some areas, the progression has been continuous.

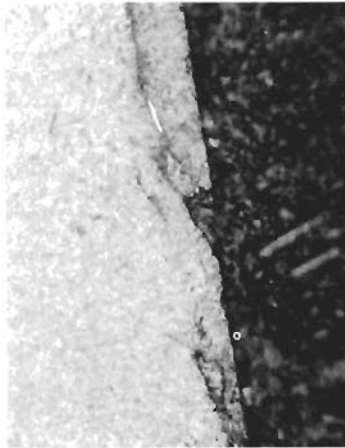
Fig. 4-14. Spiral pinion tooth, 200X. Near-pitchline pitting fatigue. Origin is subsurface at plane of maximum shear.
