Systematic Analysis of Gear Failures

Lester E. Alban

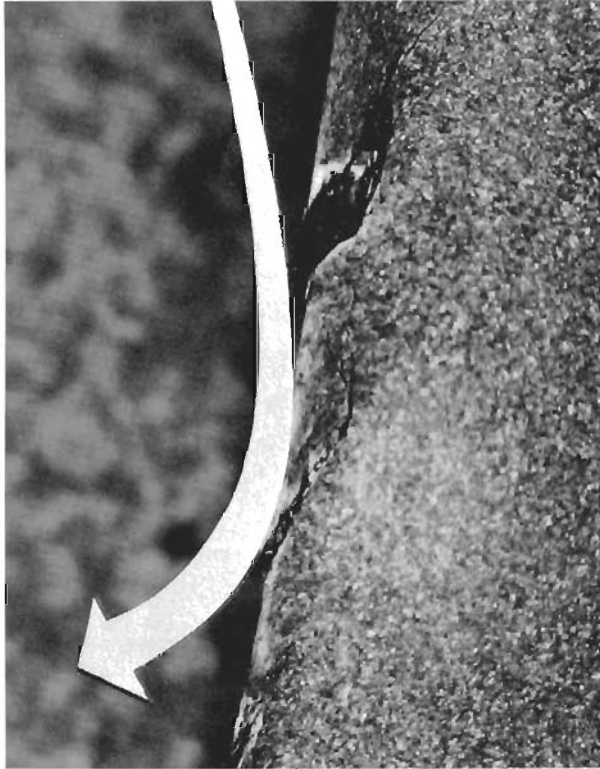
Fig. 4-15. Spiral bevel tooth, 100 \times . Nital etch. Pitting at lowest point of single tooth contact, illustrating contact path of the tip of the mating tooth.

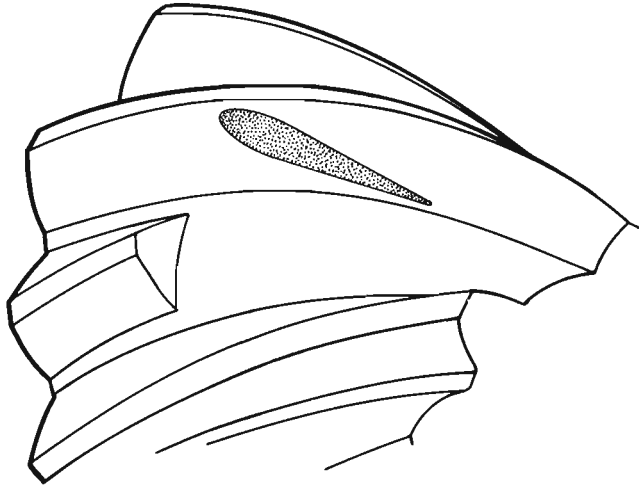
Fig. 4-16. Surface fatigue pitting initiated in a short concentrated area of a spiral bevel tooth, when that tooth was momentarily assuming full load with no help of overlap from adjacent teeth.

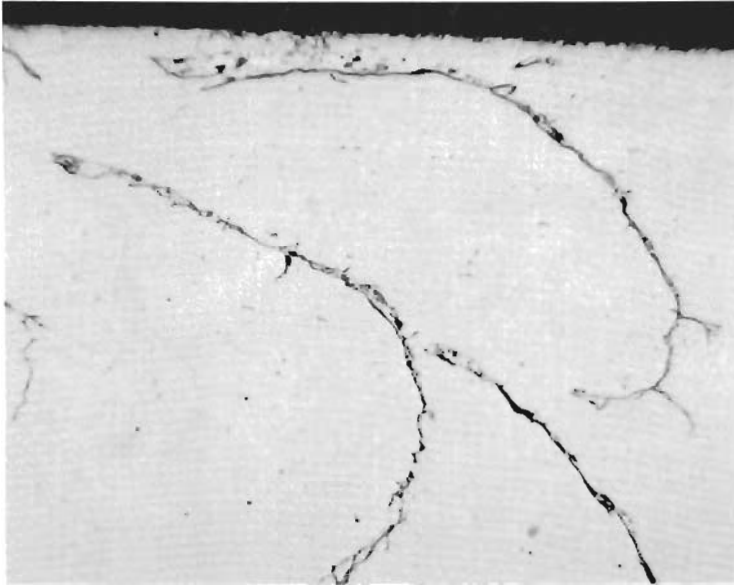
Fig. 4-17. Gear tooth section, 100 \times . Unetched. Rolling contact fatigue. Crack origin subsurface. Progression parallel to surface and inward away from surface.

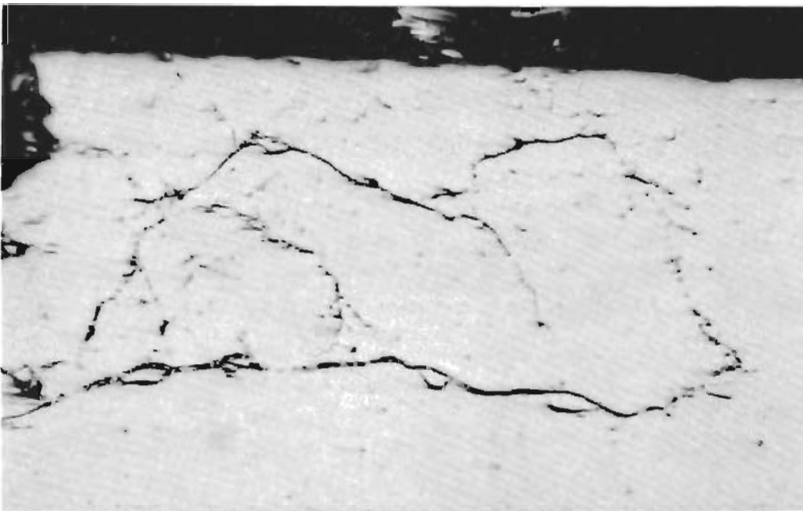
Fig. 4-18. Gear tooth section, 100 \times . Unetched. Rolling contact fatigue. Crack origin subsurface. Progression parallel with surface, inward, and finally to surface to form a large pit or spall.

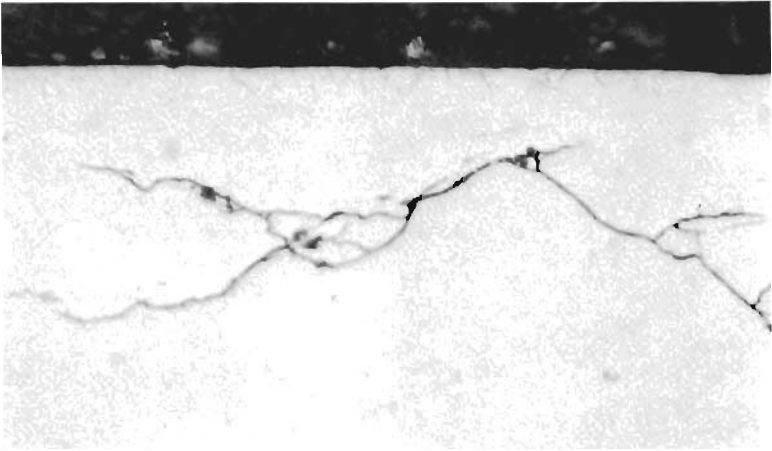
Fig. 4-19. Gear tooth section, 200 \times . Unetched. Rolling contact fatigue distinguished by subsurface shear parallel to surface. Note the undisturbed black grain oxides at the surface, indicating no surface material movement.

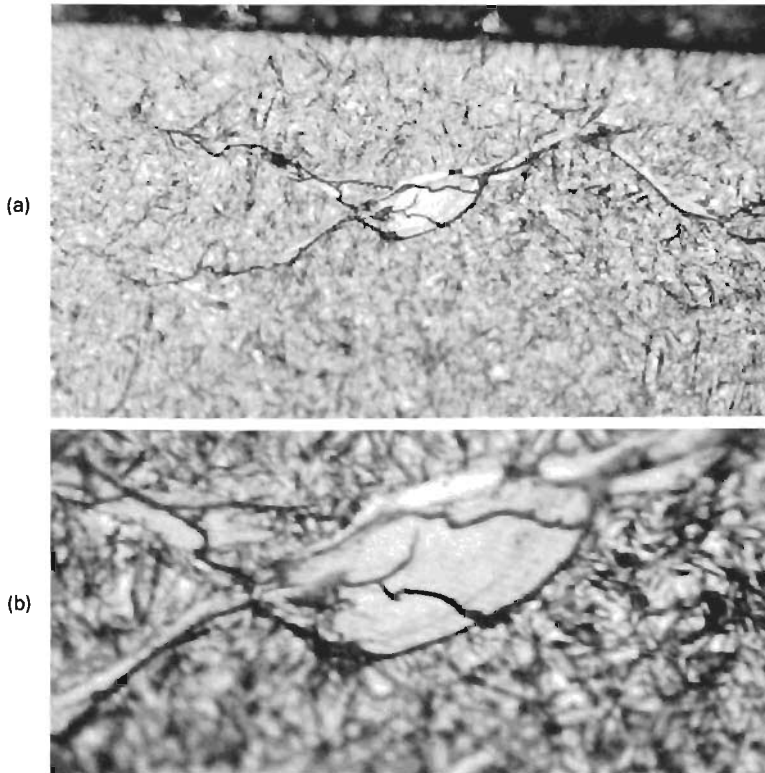
Fig. 4-20. Same sample as Fig. 4-19, 3% nital etch; at 200 \times (a) and 500 \times (b), showing details of submicrostructure called “butterfly wings.”

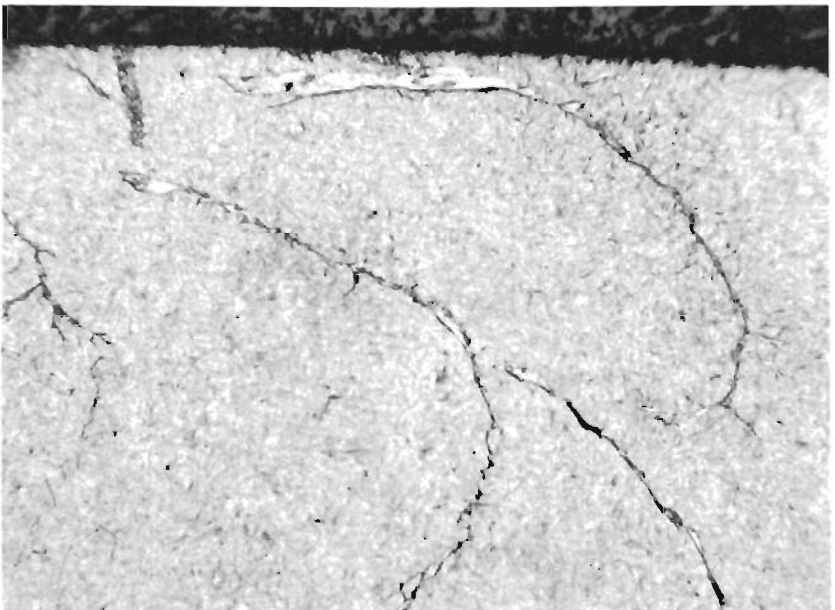
Fig. 4-21. Same sample as in Fig. 4-17. Nital etched. Note the “butterfly wings,” or altered martensite, along the shear planes.

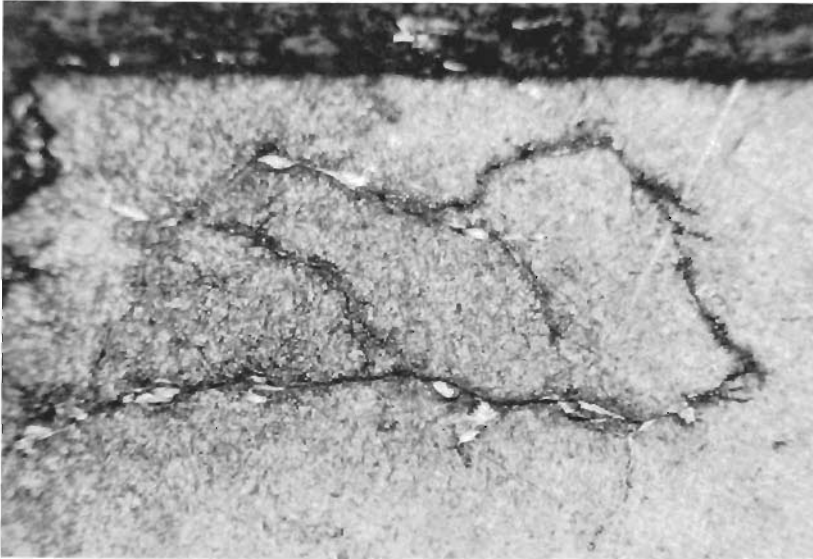
Fig. 4-22. Same sample as Fig. 4-18. Nital etched. Note the “butterfly wings,” or altered martensite, along the shear planes.

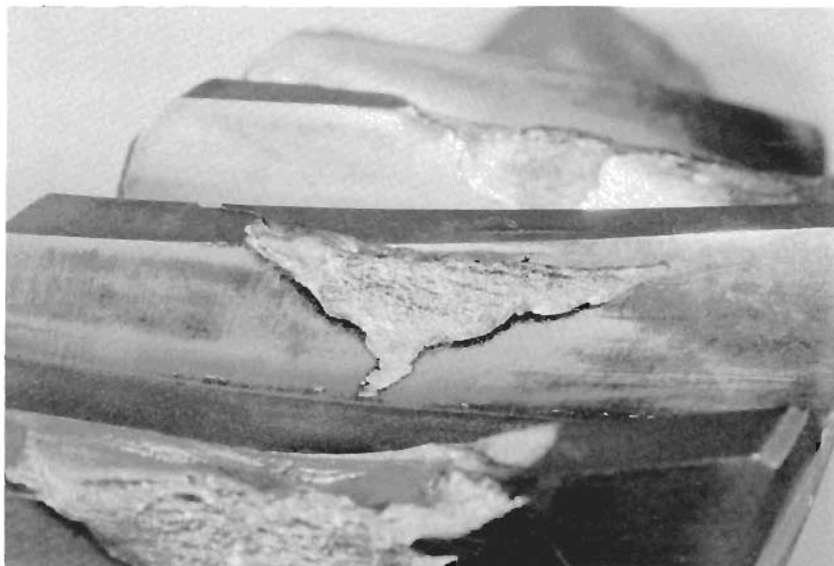
Fig. 4-23. Spiral bevel gear teeth, 1.5X. Original pitting low on the active profile gives initiation to a fast and extensive progression of spalling over the top face and down the back profile. This is often called the “cyclone effect.”

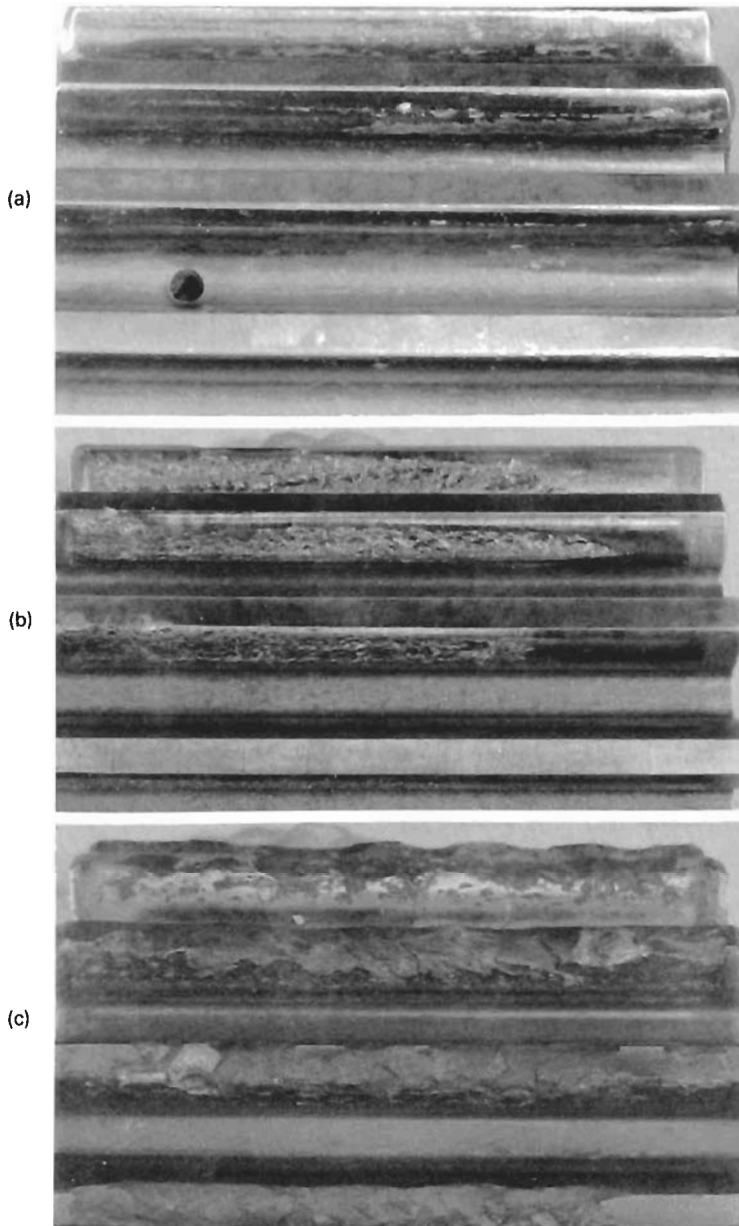
Fig. 4-24. Spur gear, 0.5X. Pitting fatigue progressing to spalling. (a) Lines of pitting just below the pitchline; (b) light spalling up and over the addendum; (c) complete spalling of all teeth.

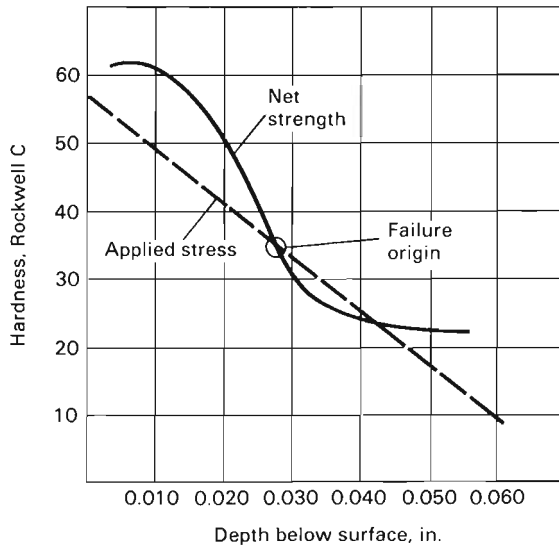
Fig. 4-25. Applied stress vs case depth (net strength).

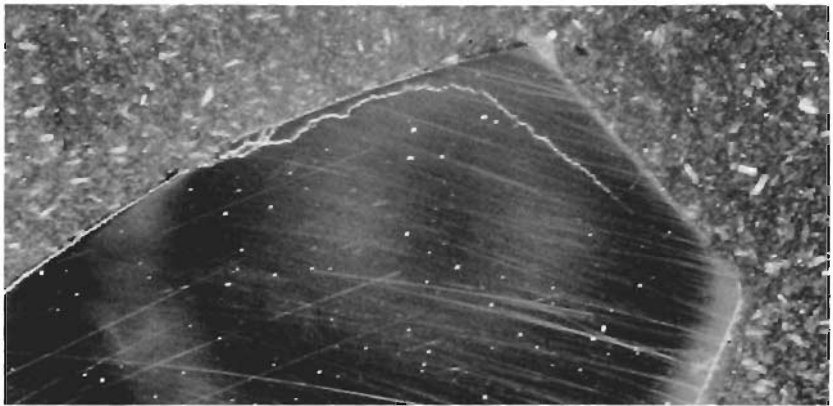
Fig. 4-26. Spalling—a subsurface fatigue failure originating at the case/core interface, subsequently progressing under the case.

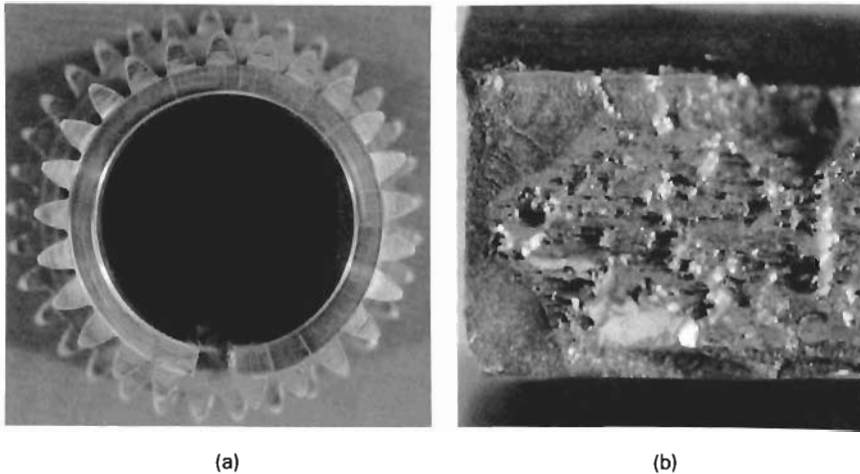
Fig. 4-27. (a) Spur gear showing radial cracking due to frictional heat against the thrust face; 0.5 \times . (b) Progression of thermal fatigue produced by the frictional heat; 2 \times .

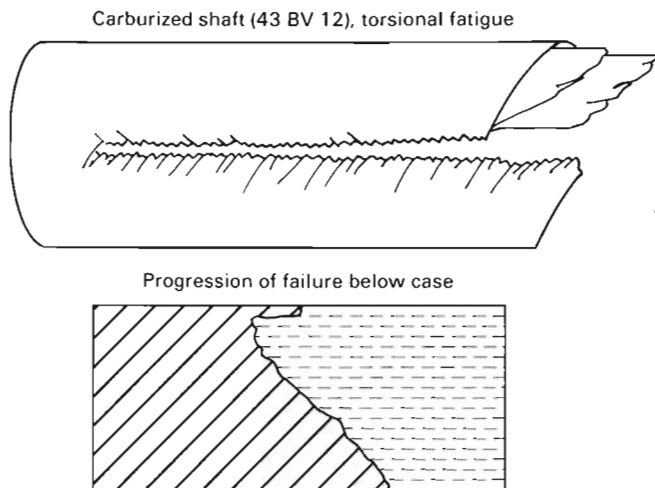
Fig. 4-28. Schematic showing subcase failure of bidirectional torsional shear fatigue followed by torsional tensile failure of the case.

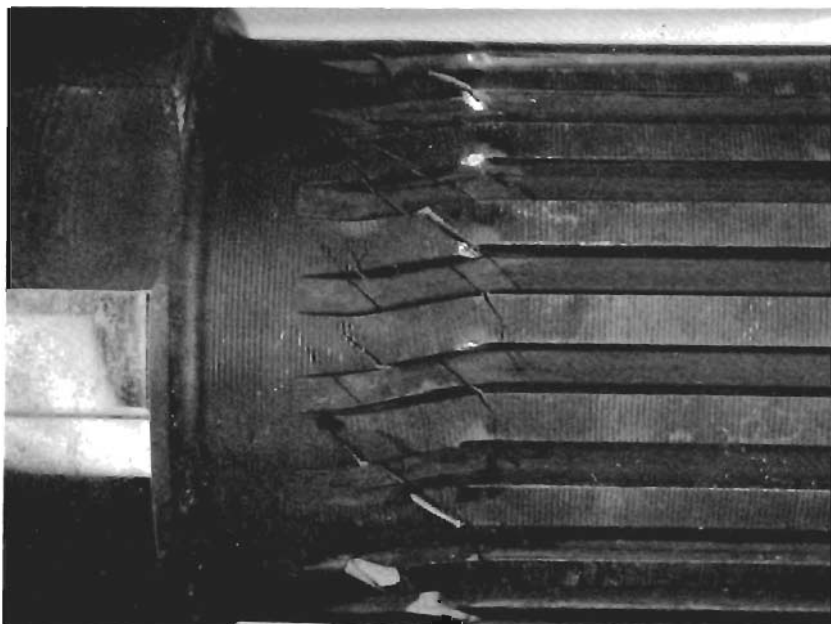
Fig. 4-29. Splined section of a pinion shank. Torsional tensile fatigue in one direction showing the 45° tensile failure lines and evidence of longitudinal shear cracking.

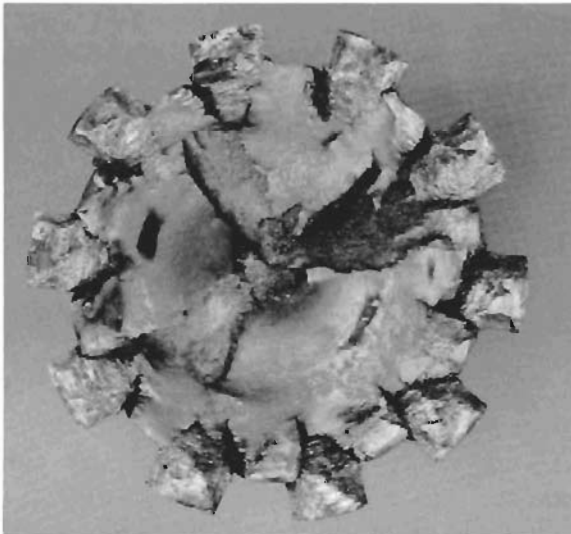
Fig. 4-30. Splined section of a shaft. The typical three-directional reversing torsional fatigue "rosette."

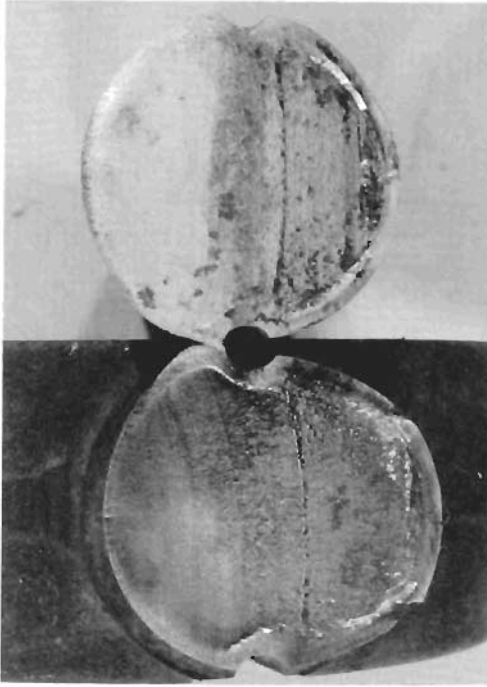
Fig. 4-31. An arm of a differential spider. Two-way bending load; mild stress concentration; very low overstress.

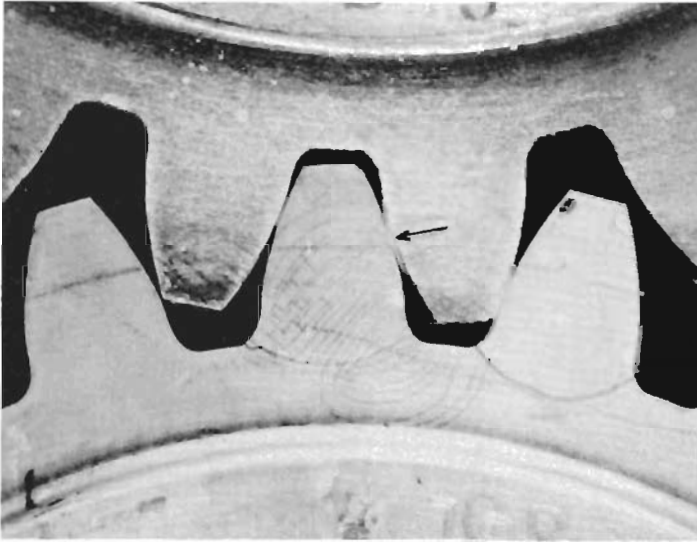
Fig. 4-35. Tooth bending impact with stress-coat overlay, showing fracture path short-circuiting the usual stress flow-lines.

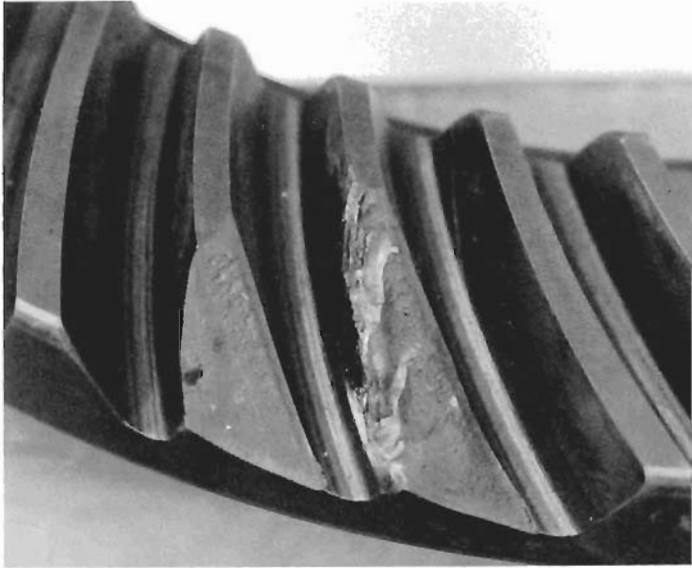
Fig. 4-36. Spiral gear teeth, 1 \times . Tooth bending impact with peak loads being applied high on the profile over the top corner of the heel end of the convex (loaded) side.

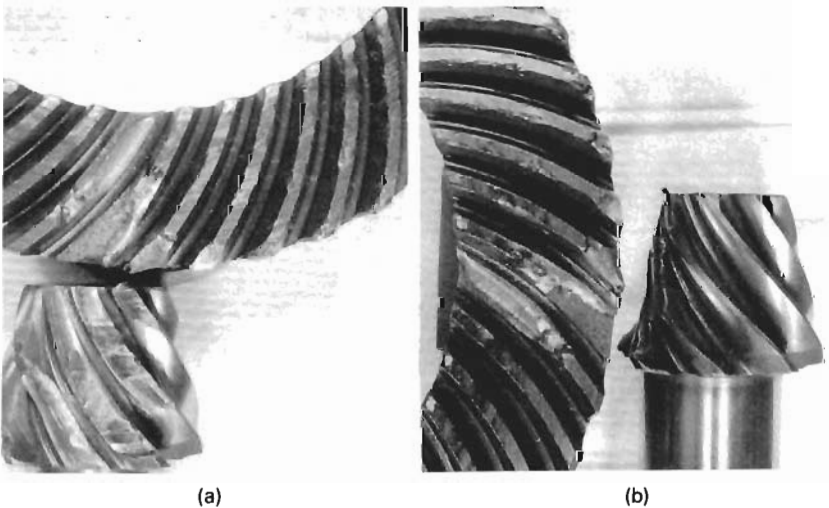
Fig. 4-37. Spiral bevel gear and pinion set, 1.5 \times . Sheared in reverse direction. The pinion came to a sudden and complete stop at the instant of a primary failure of the unit, allowing the gear to shear the contacting teeth and to continue rotating over the failed area.

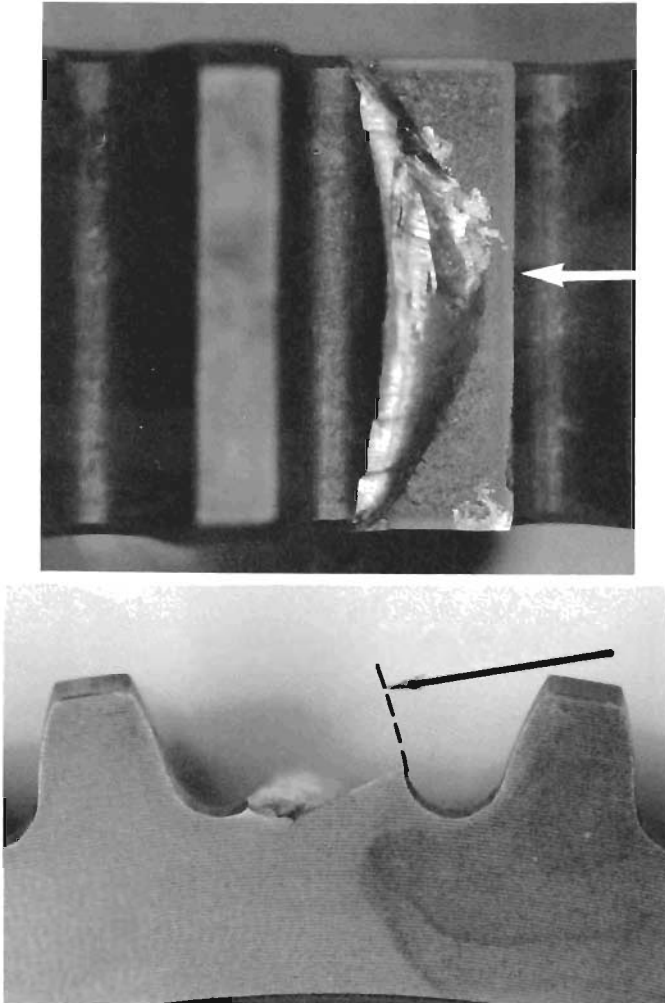
Fig. 4-38. Spur gear tooth. Combination modes: Tooth bending impact (top); tooth shear (bottom). Arrows indicate direction of applied force.

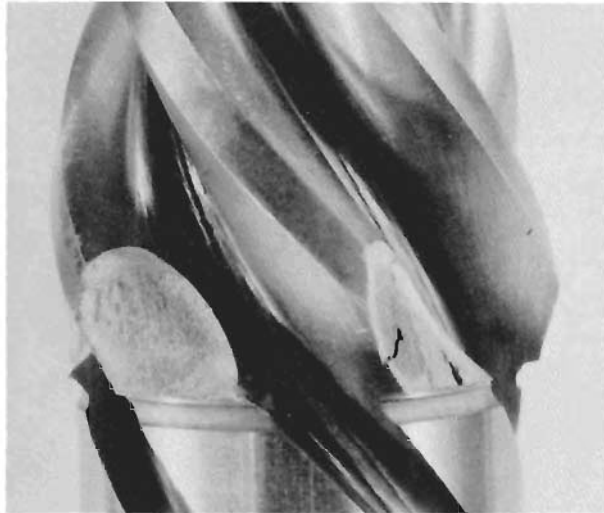
Fig. 4-39. Tooth chipping as a field failure generally shows a “pattern”; i.e., some object of impact was within the assembled unit.

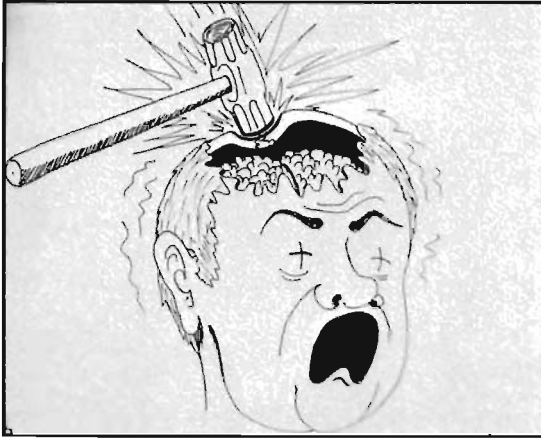
Fig. 4-40. Case crushing depends on stress applied, radius of curvature, case depth, and core hardness.

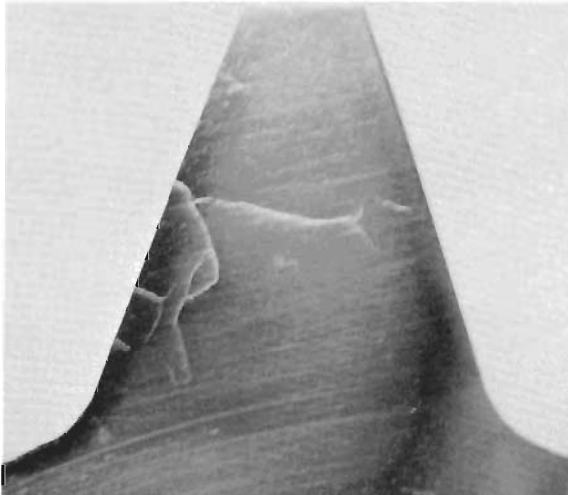
Fig. 4-41. Case crushing at midprofile of a spiral bevel gear tooth. Progression is from the subcase area into the core and outward to the surface.

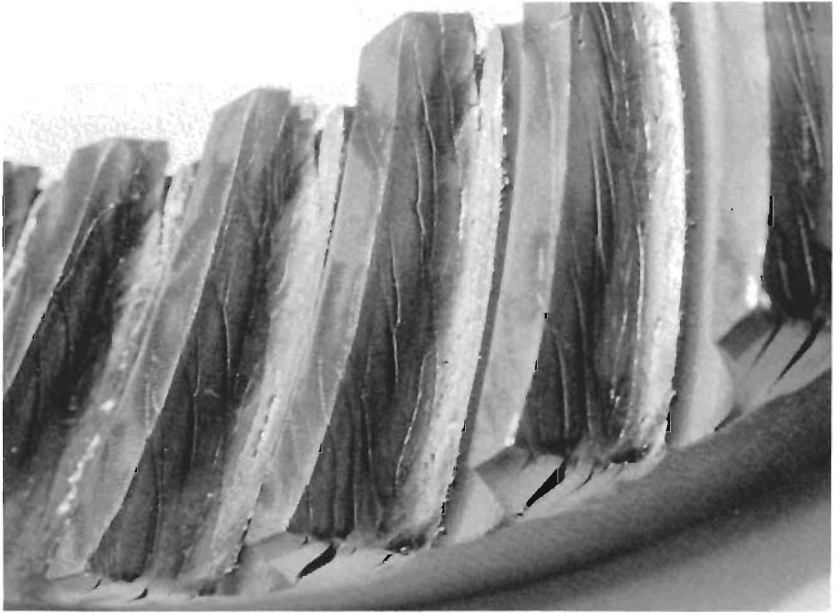
Fig. 4-42. Extensive case crushing. Heavy loads, thin case, soft core.

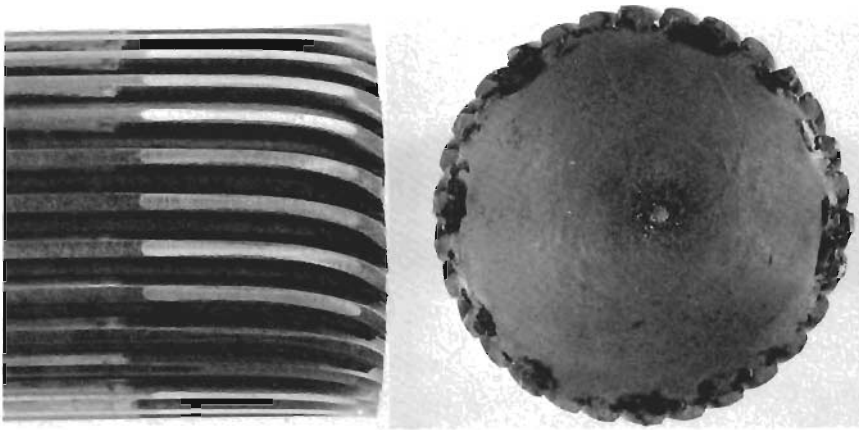
Fig. 4-43. Torsional shear. Suddenly applied extreme torsional overload.

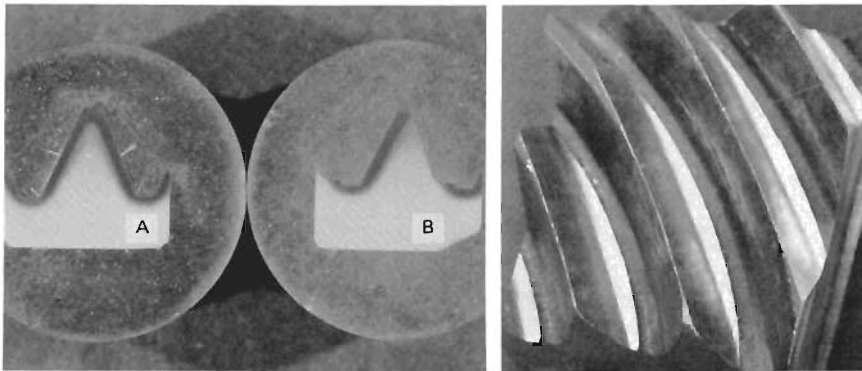
Fig. 4-44. Spiral bevel gear teeth showing contact wear. Insert A is a tooth area nonworn. Insert B shows abrasive wear clearly cutting away 1/8 in. of the surface without damage to underlying material.

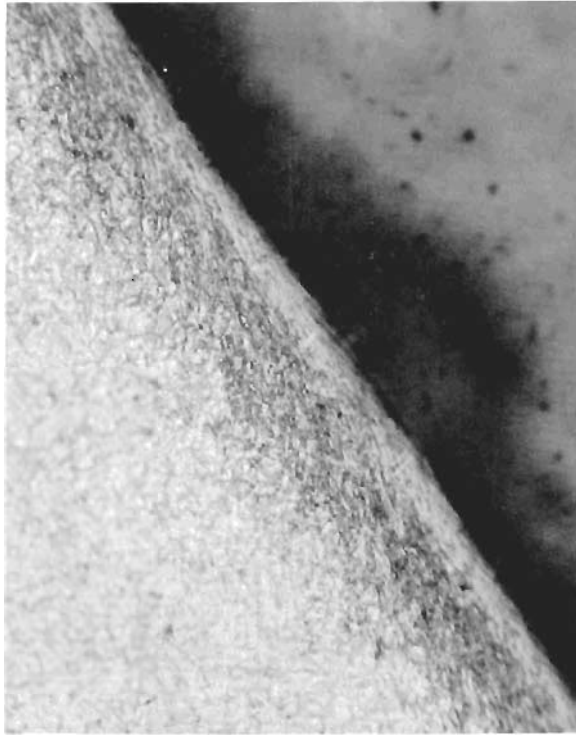
Fig. 4-45. Pinion tooth profile, 100 \times . Glazed surface showing the start of catastrophic movement of surface material. Frictional heat has already started to temper the surface.

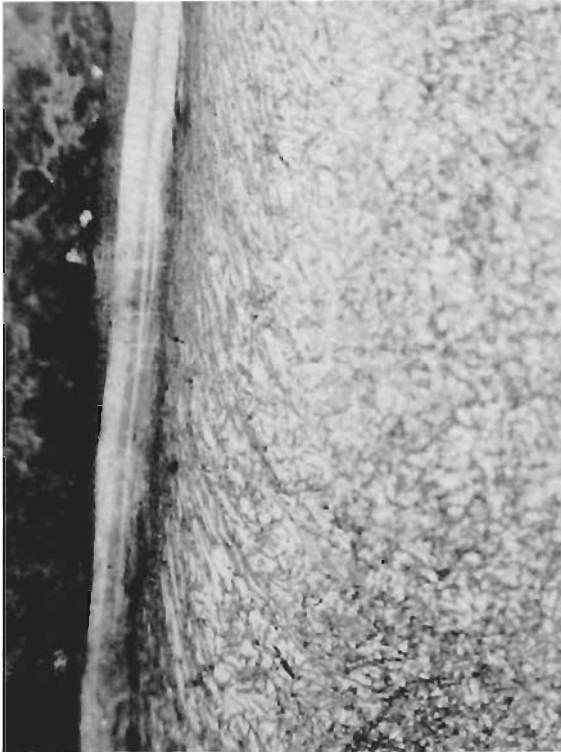
Fig. 4-46. Pinion tooth profile, 100 \times . Plastically deformed by frictional heat and sliding pressures. Surface layer has locally rehardened and galling is evident.

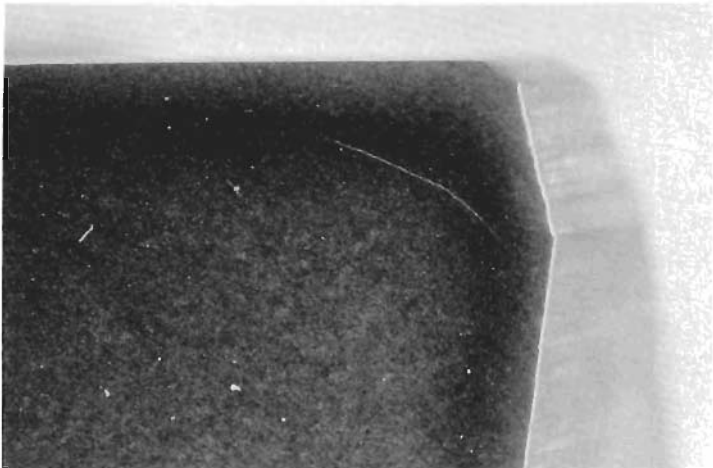
Fig. 4-48. Spiral bevel gear tooth. Internal rupture at top corner of case/core interface.

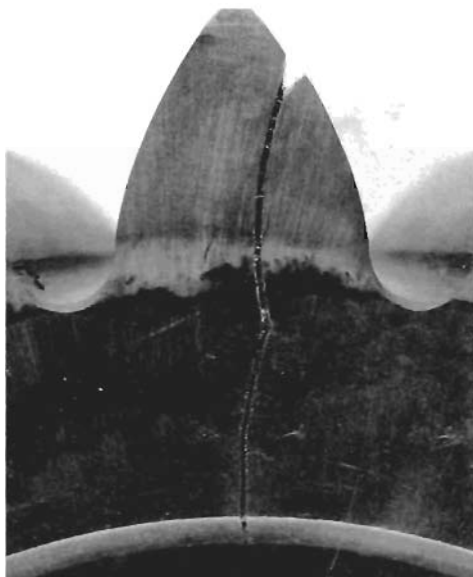
Fig. 4-50. Spur gear. External rupture (assembled, but not in service) with origin at the end face. (See Fig. 3-5 and 4-51.)

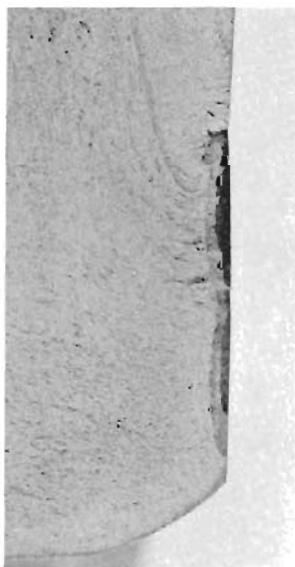
Fig. 4-51. Spur gear. External rupture originating from a grinding check. (See Fig. 3-5 and 4-50.)

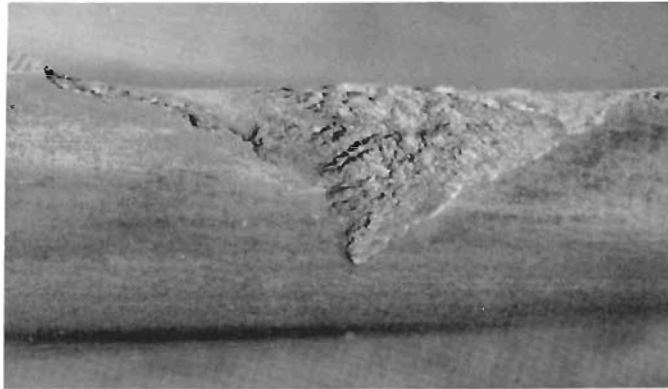
Fig. 5-1. Helical gear tooth, 1 \times . Pitting/spalling mode originating at a pit caused by subsurface fatigue around a small nonmetallic inclusion. Only one tooth affected. An isolated, random case.

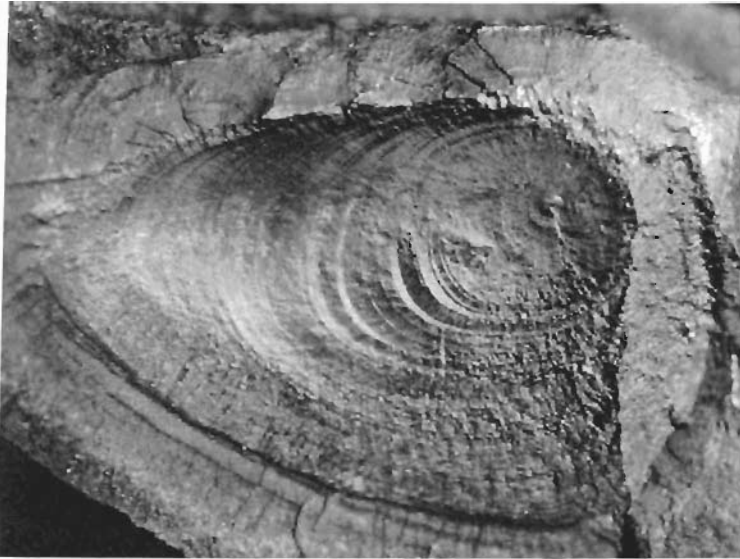
Fig. 5-2. Top corner of a spur gear tooth, 10 \times . A “bull’s-eye” fatigue fracture centering around a nonmetallic inclusion at the case/core interface. Only one tooth spalled. An isolated, random case.

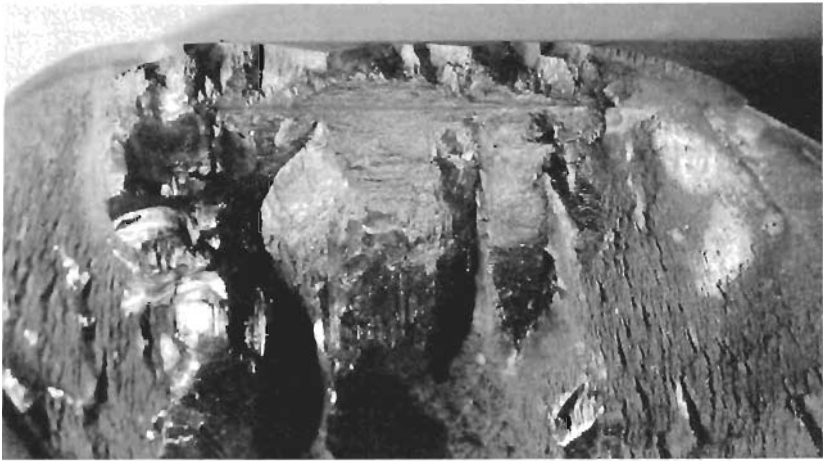
Fig. 5-3. Torsion fatigue in the longitudinal shear plane centering along an elongated inclusion below the case/core transition zone.

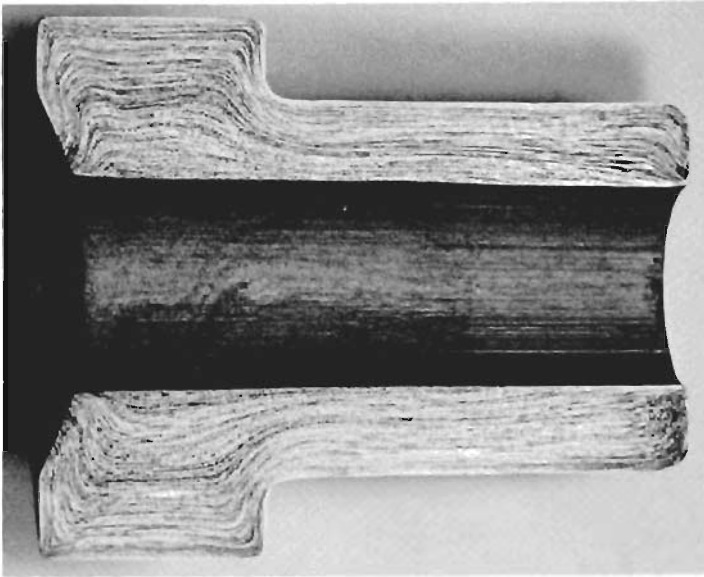
Fig. 5-4. Normal hot rolled steel bar flow lines have been pressed into a forging-die cavity to strengthen the ultimate product.

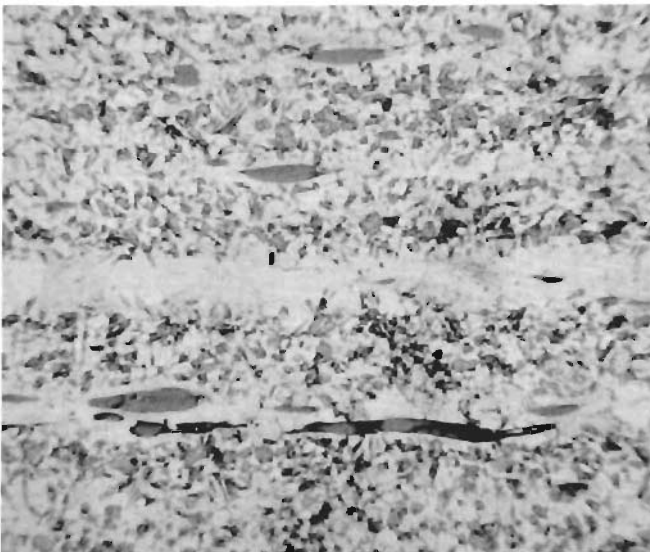
Fig. 5-5. Microstructural banding shows alternating layers of ferrite and pearlite. Nonmetallic inclusions tend to follow the ferrite bands.

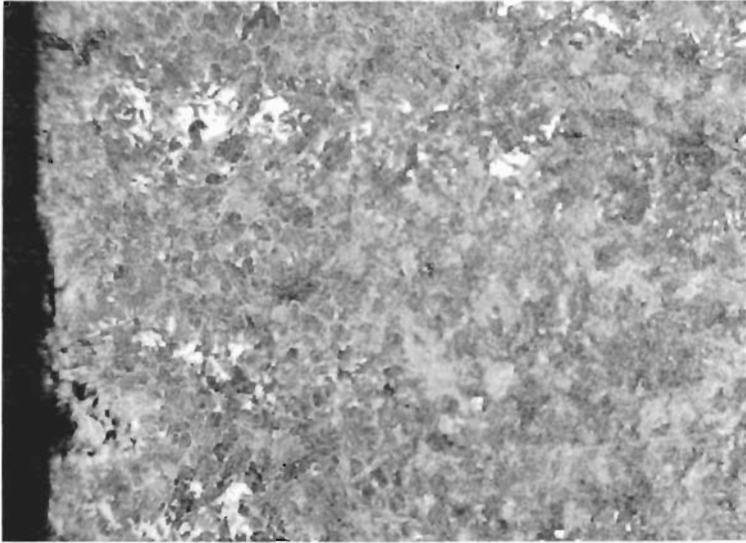
Fig. 5-6. Banding influences the diffusivity of carbon during carburizing. Note the resulting banded areas of retained austenite (white structure).

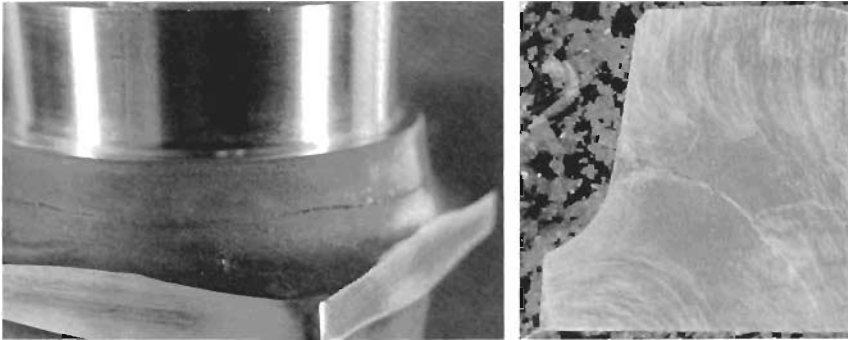
Fig. 5-7. Forging lap around a forged hub. Crack followed the normal flow-line pattern and retained oxidized scale along its surface.

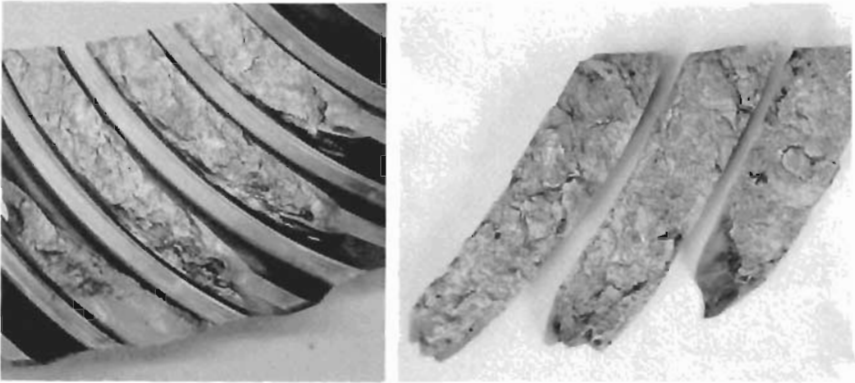
Fig. 5-8. Burned forging. A localized area of exceptionally large-grain structure with oxides, voids, segregation, and cracks within the grain boundaries.

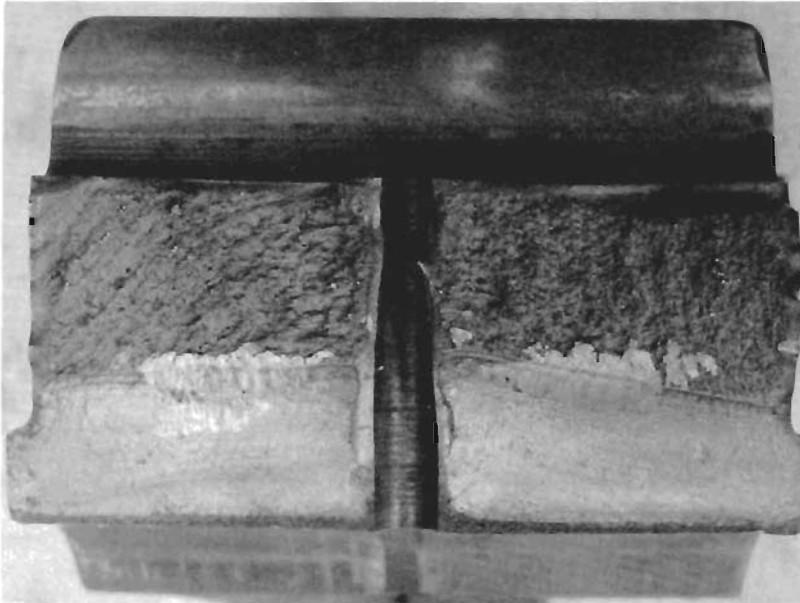
Fig. 5-9. Spur idler gear, 1 \times . Fatigue crack origin in the bore at each of the six oil holes.

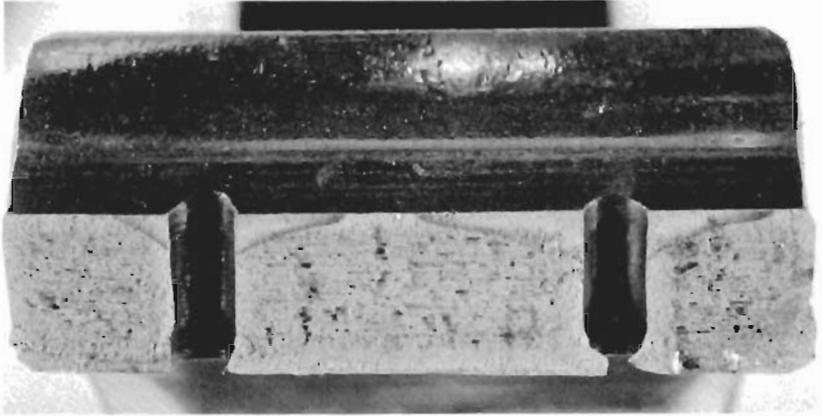
Fig. 5-10. Spur idler gear, 2.7 \times . Fatigue crack origin in tooth root at oil holes. Final fracture was rapid.

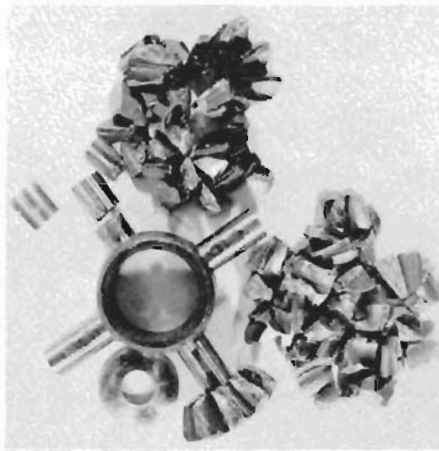
Fig. 5-11. Differential internal spider and pinions. Fatigue cracking origin at toe end of the root to bore section, which is rather thin.

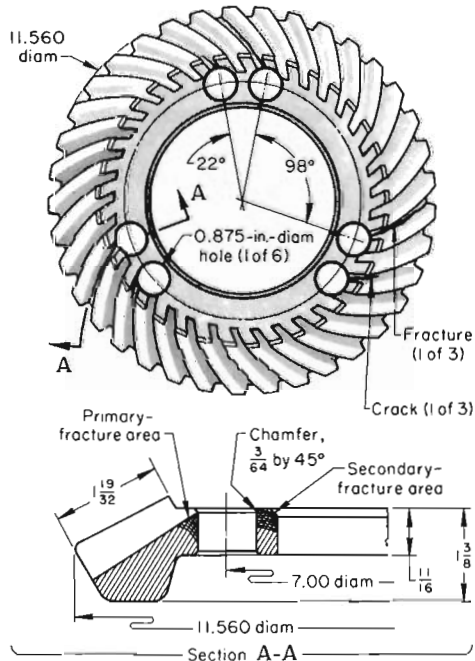
Fig. 5-12. Carburized spiral bevel gear fractured from fatigue originating at the acute angle intersection of the root fillet to the bolt hole.⁵

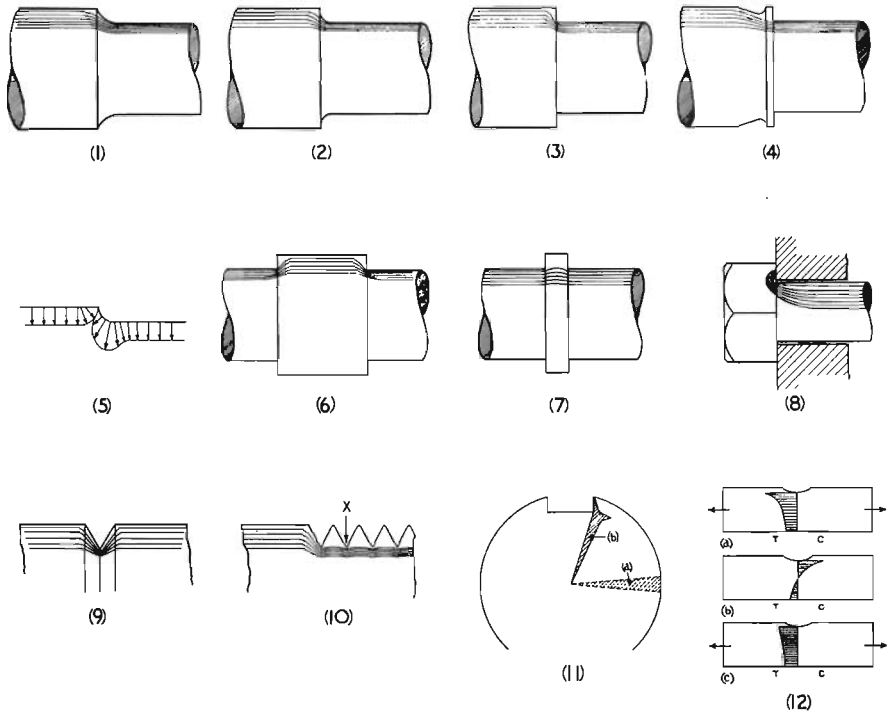
Fig. 5-13. Stress distribution at changes of section.⁶

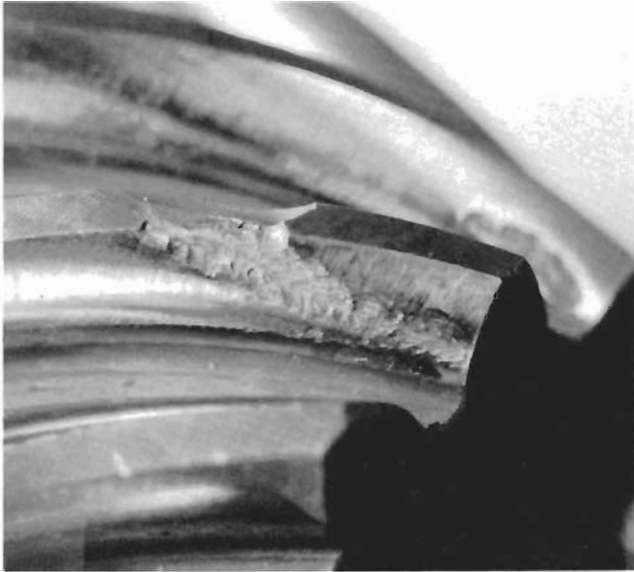
Fig. 5-14. Spiral bevel tooth, 2 \times . Pitting and spalling due to rolling contact fatigue in a concentrated area (see Fig. 4-16) as a designed failure.

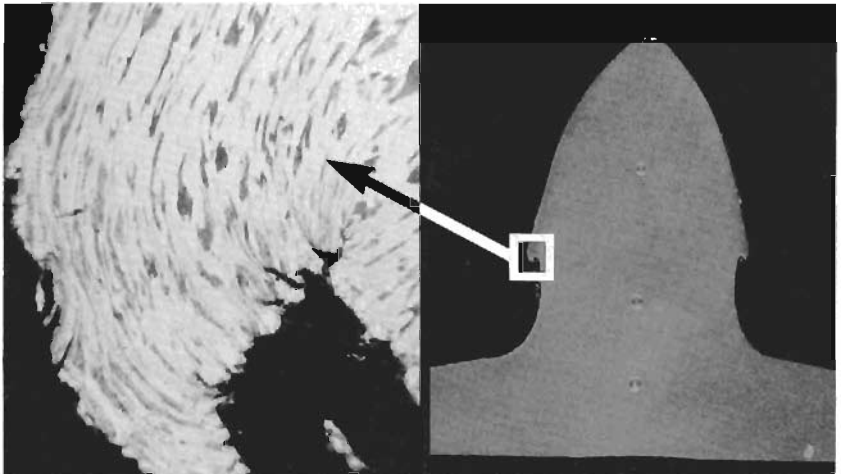
Fig. 5-15. A gear made from C1019 carbon steel (annealed) used to replace an SAE 8620 alloy steel (carburized).

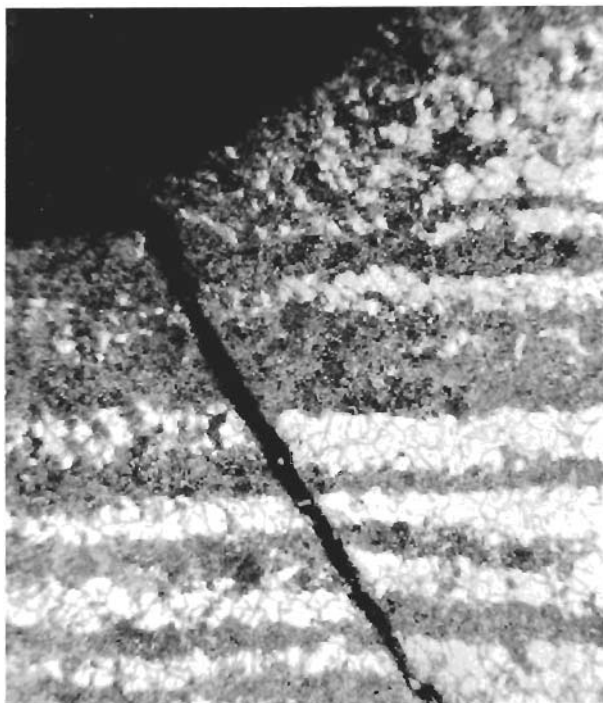
Fig. 5-16. Shoulder radius next to a bearing diameter. Carburized case had been removed by grinding, allowing a fatigue failure in bending due to low strength of surface material.

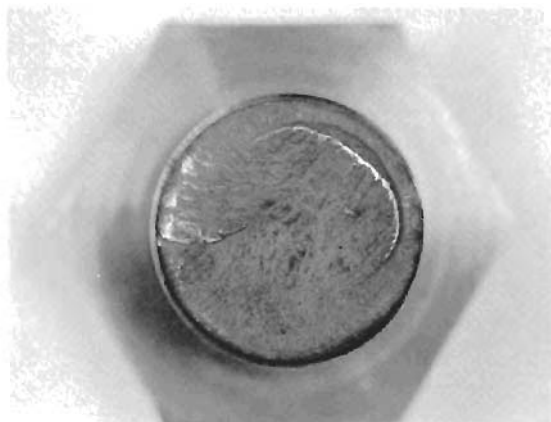
Fig. 5-17. Rapid fatigue at the base thread of a differential holding bolt (grade 8).

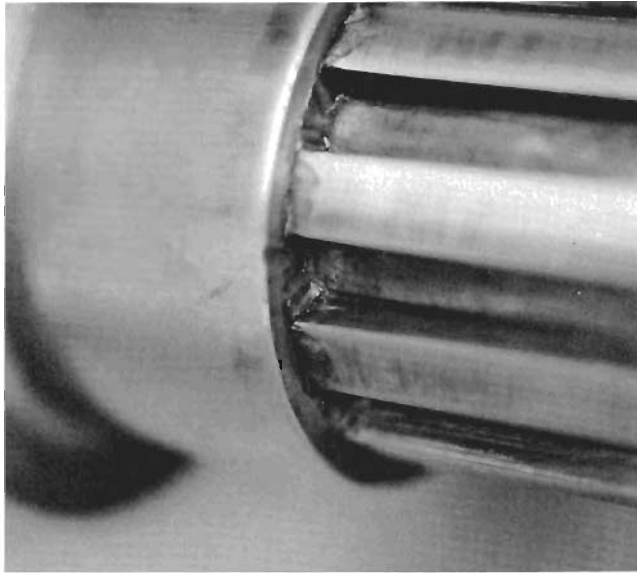
Fig. 5-18. Each individual spline had been formed with a vertical milling cutter. The rounded area at the shoulder was swaged into square corners with a hammer and chisel. Each corner was precracked, which resulted in a fatigue failure.

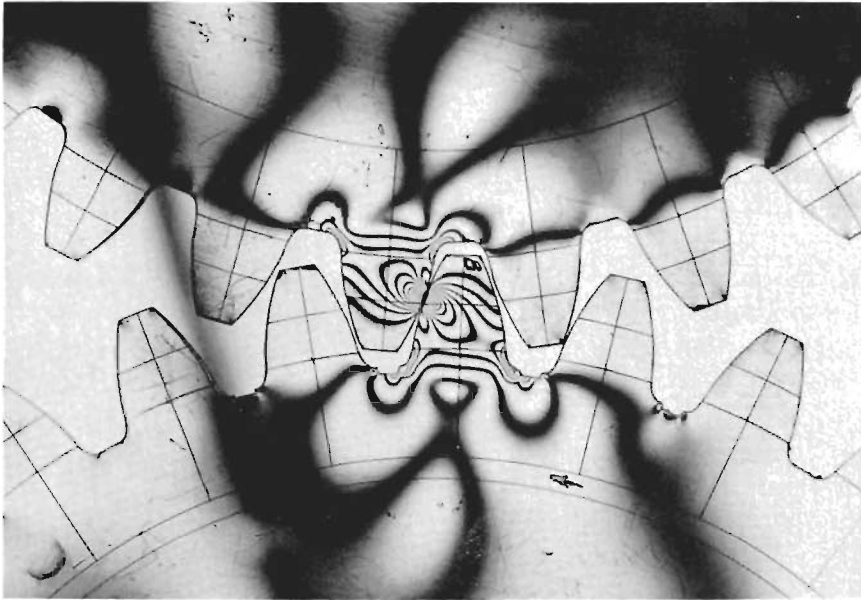
Fig. 5-19. Photoelastic study of the effect of a roughing cutter mark on tooth bending strength. The rounded fillets were loaded to an equivalent of 6.5 stress fringes. The cutter mark (0.022-in. deep) measured 6.0 stress fringes at its radius. A stress concentration equivalent to 92% of the applied load.

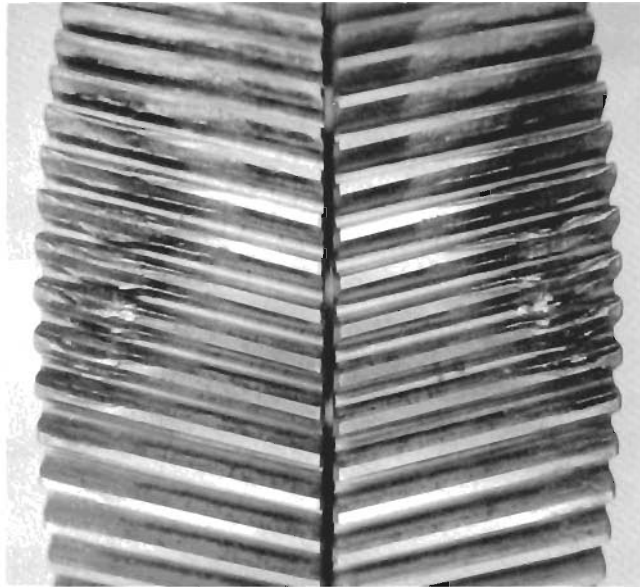
Fig. 5-20. Double helical gear. Severe frictional heat developed due to runout and taper in the gear. The heated section had less than zero backlash.

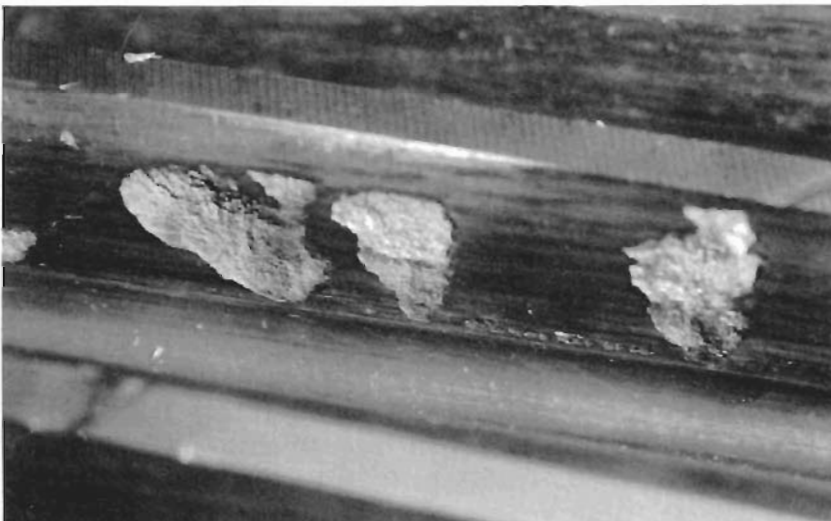
Fig. 5-21. Tooth tip interference causing in-line pitting low on the active profile. A spalling action has resulted.
