Systematic Analysis of Gear Failures

Lester E. Alban

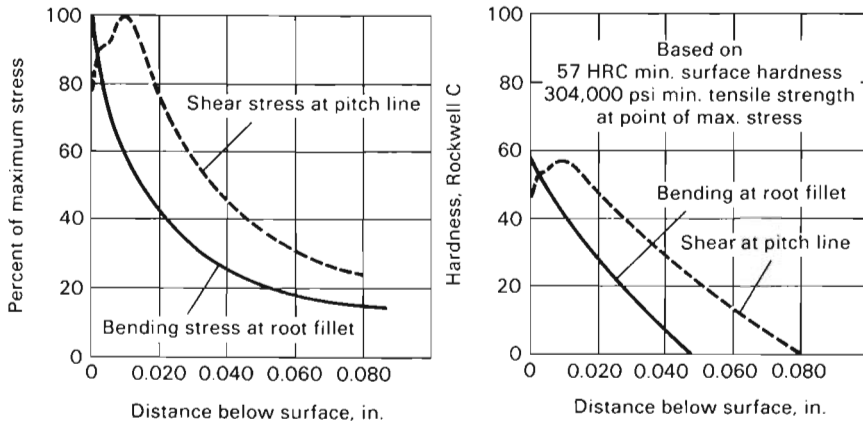
Fig. 5-22. Subsurface stresses (left) and the hardness gradients necessary to prevent subsurface failure (right); shown for a 7-pitch spur gear.

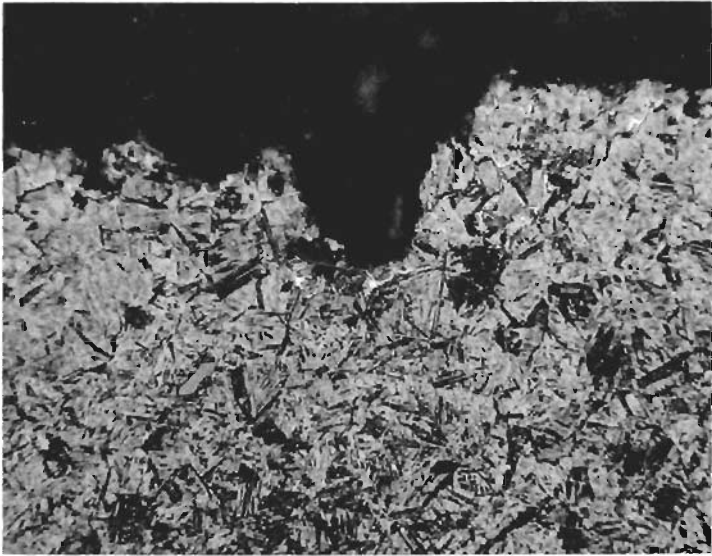
Fig. 5-23. Carburized surface that crumbled under load along the carbide network boundaries, 200 \times .

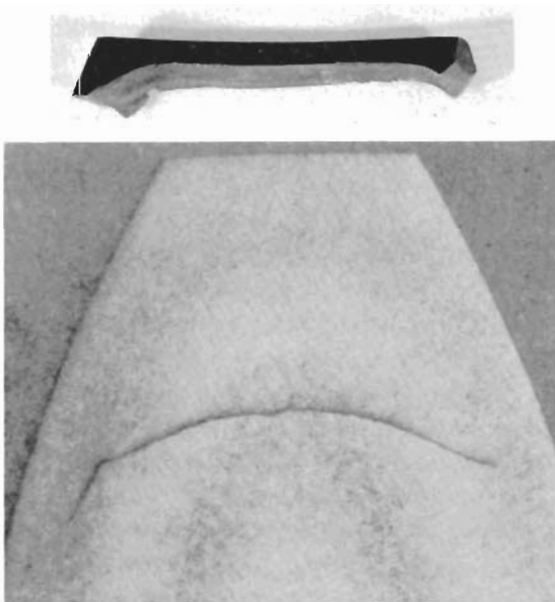
Fig. 5-24. Internal stress rupture. Origin at case/core interface near top of tooth. In extreme cases, the entire tooth top may pop off.

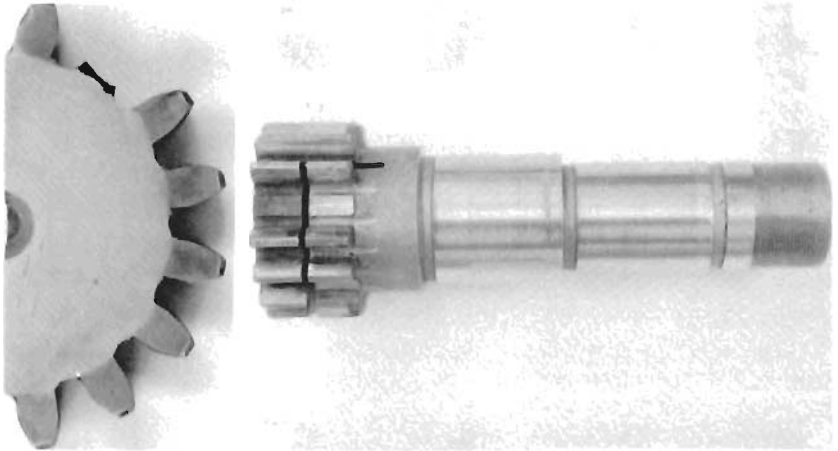
Fig. 5-25. Spur pinion induction hardened by using a single round coil. Hardened area terminus at the root fillet end face set up a stress notch that invited failure by tooth bending fatigue.

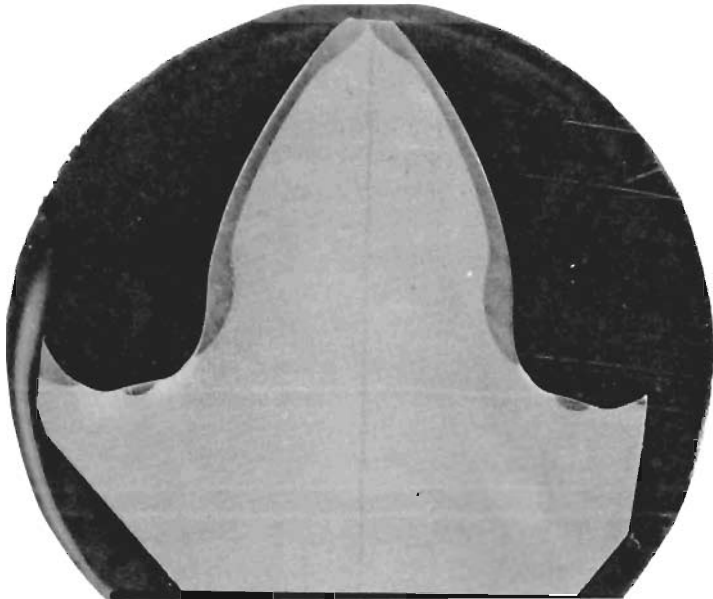
Fig. 5-26. Spur tooth induction hardened by scanning one tooth space at a time. Inductor scanning speed did not allow time for heat to penetrate the root radius. A stress notch resulted which invited failure by tooth bending fatigue.

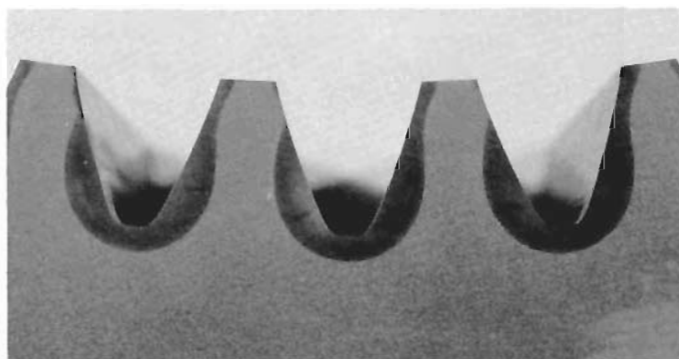
Fig. 5-27. Internal spur gear induction hardened by scanning one tooth space at a time. The inductor was misaligned, allowing for a nonhardened addendum on one tooth profile. This soft area was easily worn.

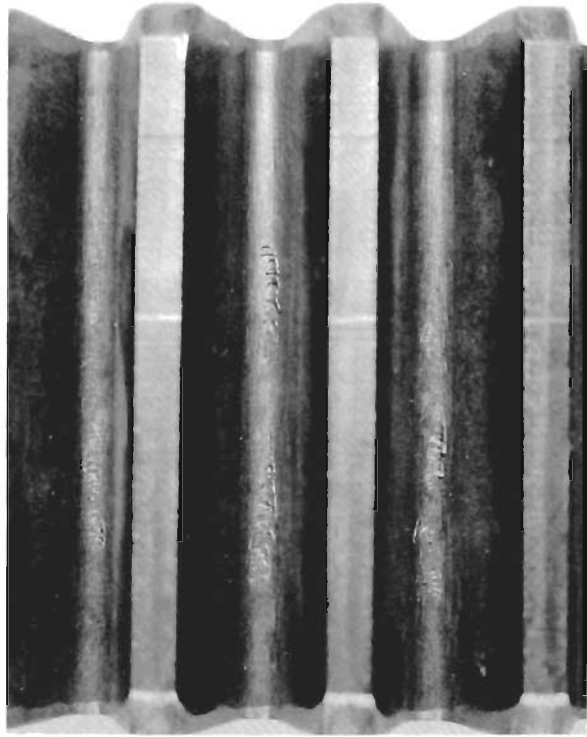
Fig. 5-28. A tooth space inductor set too close to the root caused severe burning and melted material at the root centers of several teeth.

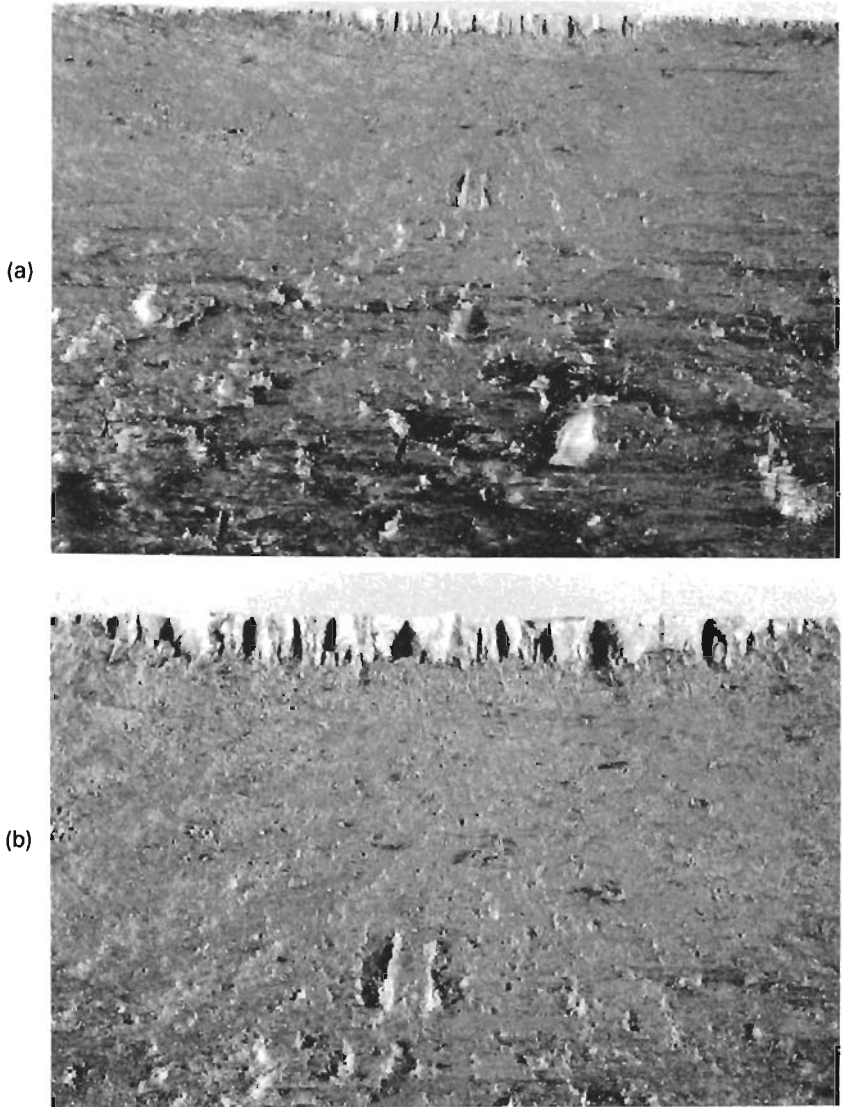
[a] 1.6X. The proximity of a long inclusion that was not a factor in this failure. [b] 3.5X. The columnar structure is the result of ram pressure from a straightening press. The crushing effect of the case into the core formed a weakened case/core interface which became the origin for shear fatigue.

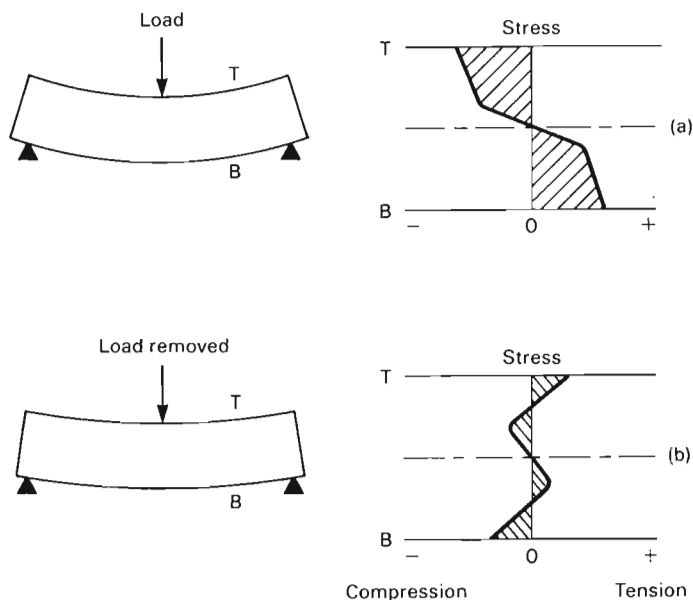
Fig. 5-30. Residual stresses in a shaft due to plastic bending during a straightening operation. (a) Stress distribution during plastic bending. (b) Residual stress measured after load removal.⁹

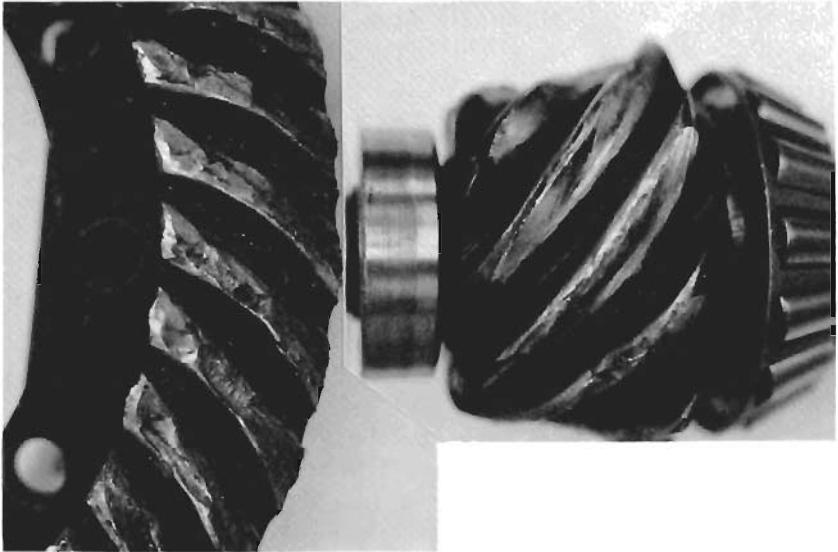
Fig. 5-31. Spiral bevel pinion (0.75 \times) and gear (0.70 \times) from a stock item differential manufactured properly for and adjusted to a right-hand drive. It was installed in a left-hand drive situation. The reverse-side pattern had not been corrected for this application.

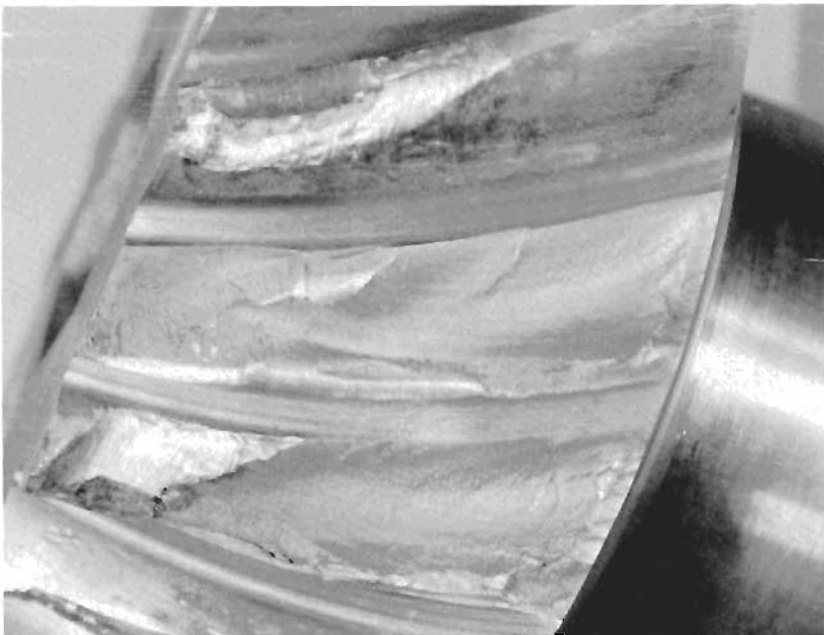
Fig. 5-32. Spiral bevel pinion, 1.0X. Tooth bending fatigue toward the heel end caused by misalignment in the assembly 0.020 in. out and 0.020 in. back from the gear.

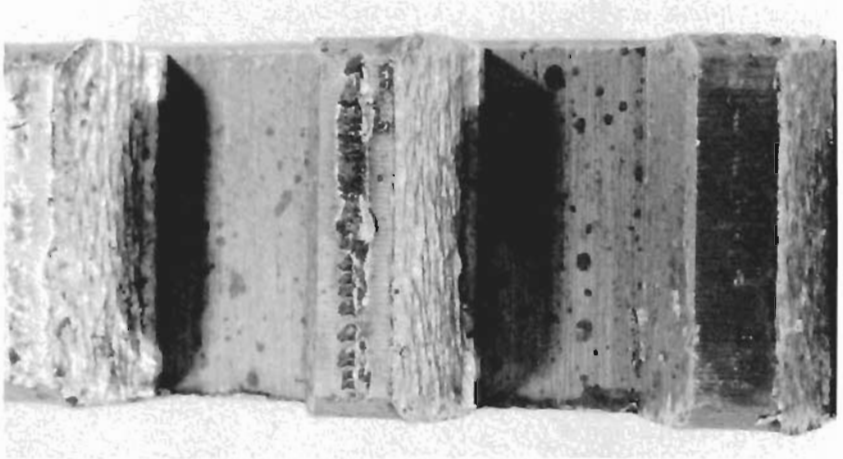
Fig. 5-33. A hub spline that permanently fitted into a wheel gear. Vibrations advancing to chatter, along with foreign particles, set up a destructive wear condition.

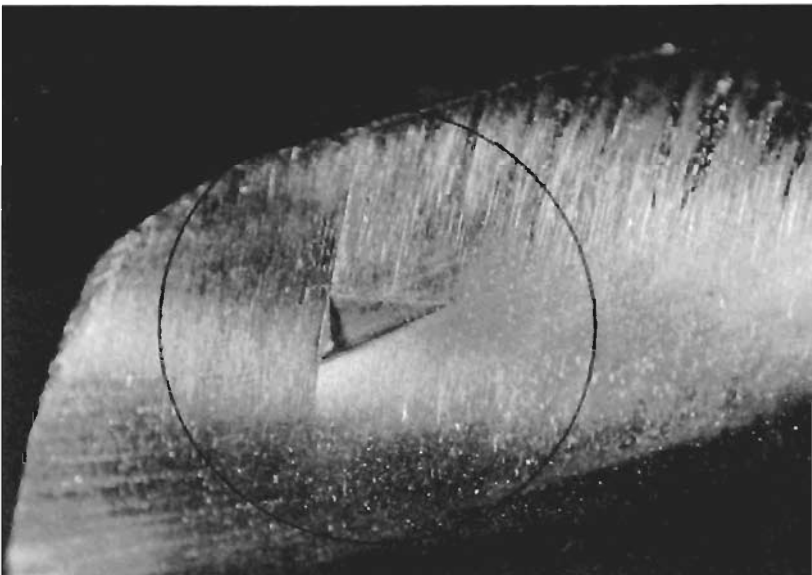
Fig. 5-34. Spiral bevel gear tooth, 3 \times , showing surface gouge due to the breaking of a cutter blade.

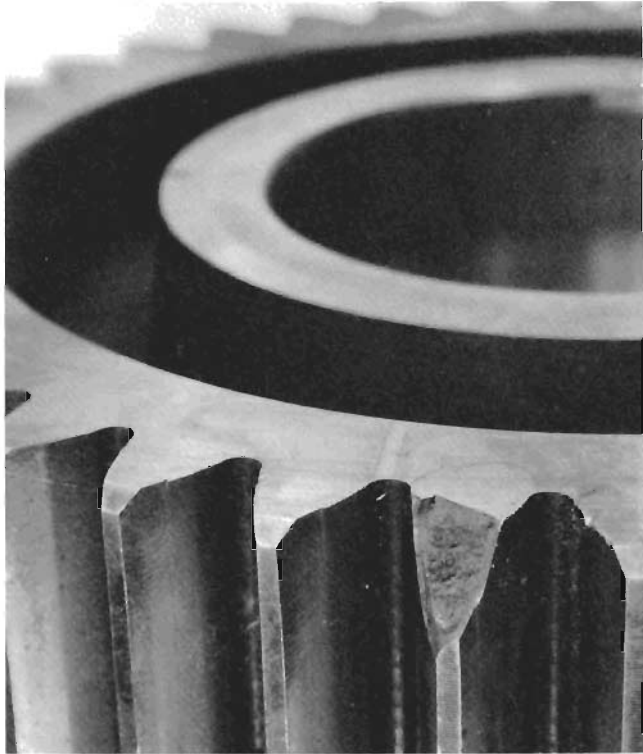
Fig. 5-35. Spur gear damaged by the impact of a dropped gear.

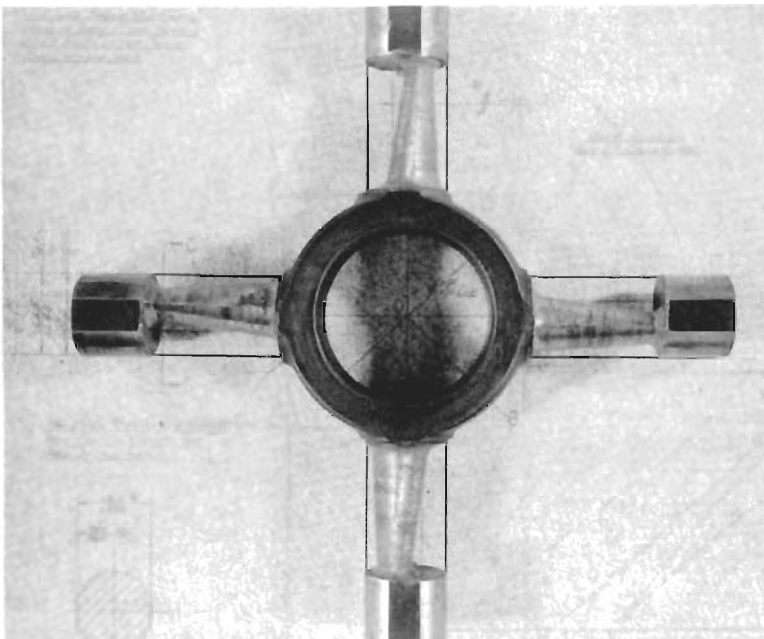
Fig. 5-36. Differential spider arms worn deeply by abrasive material as a contaminant in the lubricant.

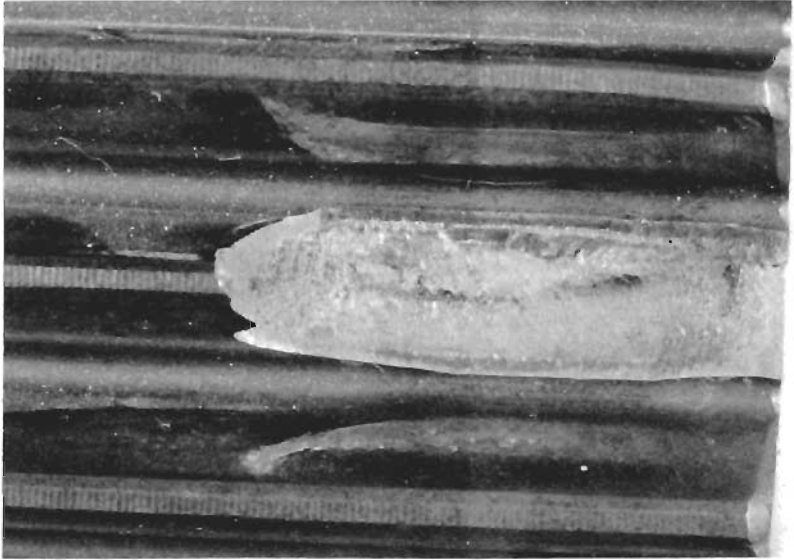
Fig. 5-37. Spur gear, 3 \times . Tooth bending fatigue with origin from a crack at both root radii caused by the enmeshing of a portion of a needle bearing roller.

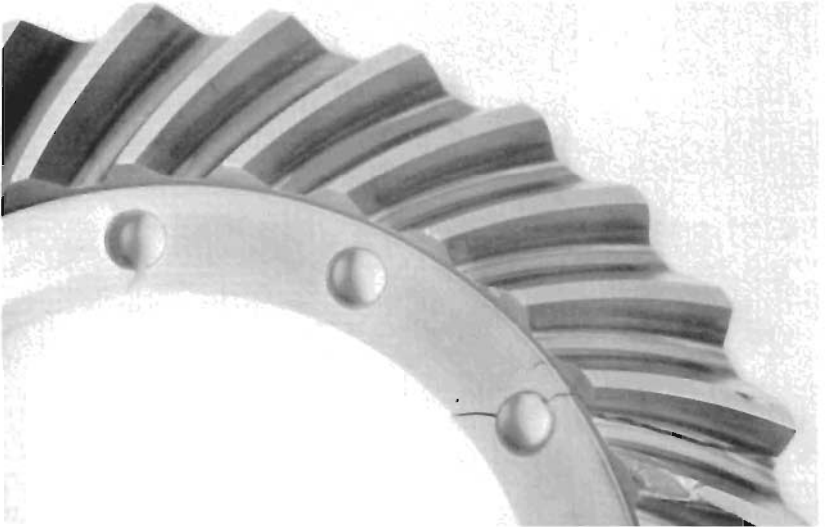
Fig. 5-38. A foreign object (top of adjacent tooth) became enmeshed in spiral gear (0.5 \times) teeth causing a full section break. The top of the adjacent tooth also broke by impact from some object.

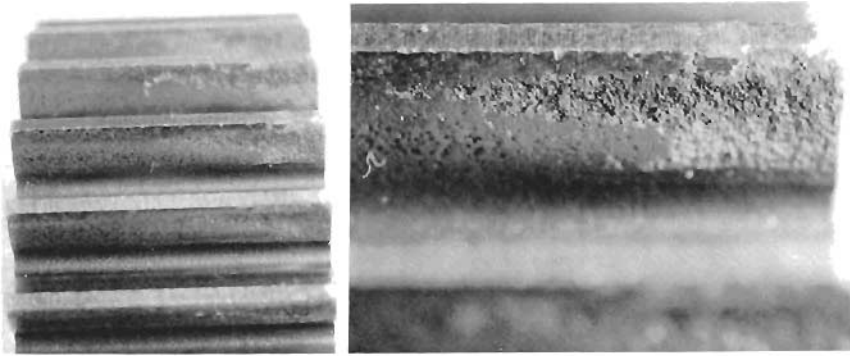
Fig. 5-39. Spur gear used in a seasonal operation was at the top of an assembly, out of the oil, and subject to corrosion by cold weather condensation during the idle season.

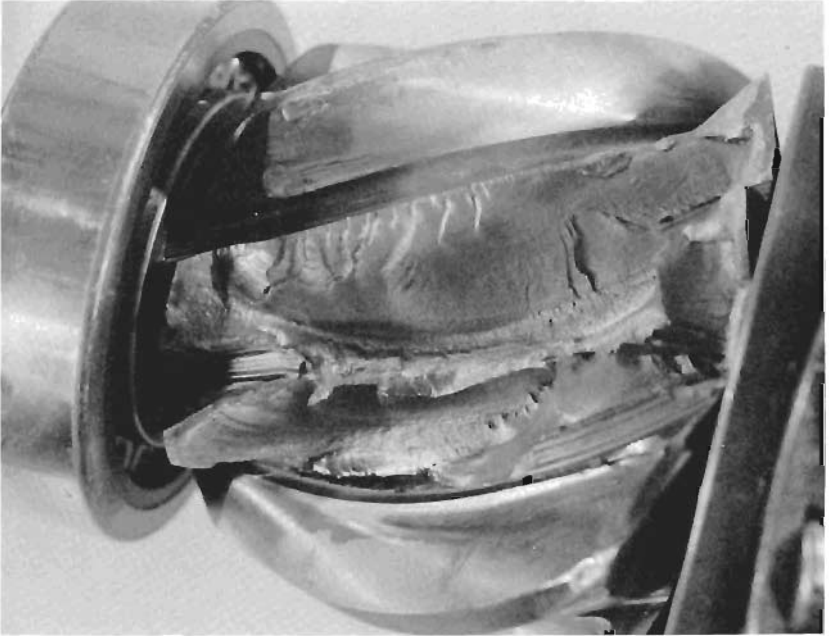
Fig. 5-40. Spiral bevel pinion, 0.6 \times . Two teeth out by tooth bending fatigue, but all teeth are fractured almost completely through. Continual overload.

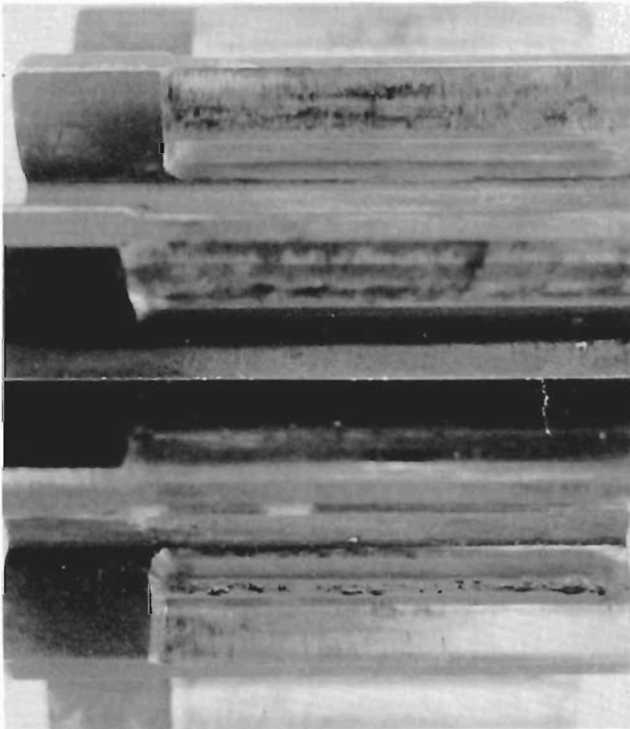
Fig. 5-41. Spur gear, 0.9X. High continual overloads broke down the lubricant barrier, causing deep adhesive wear.

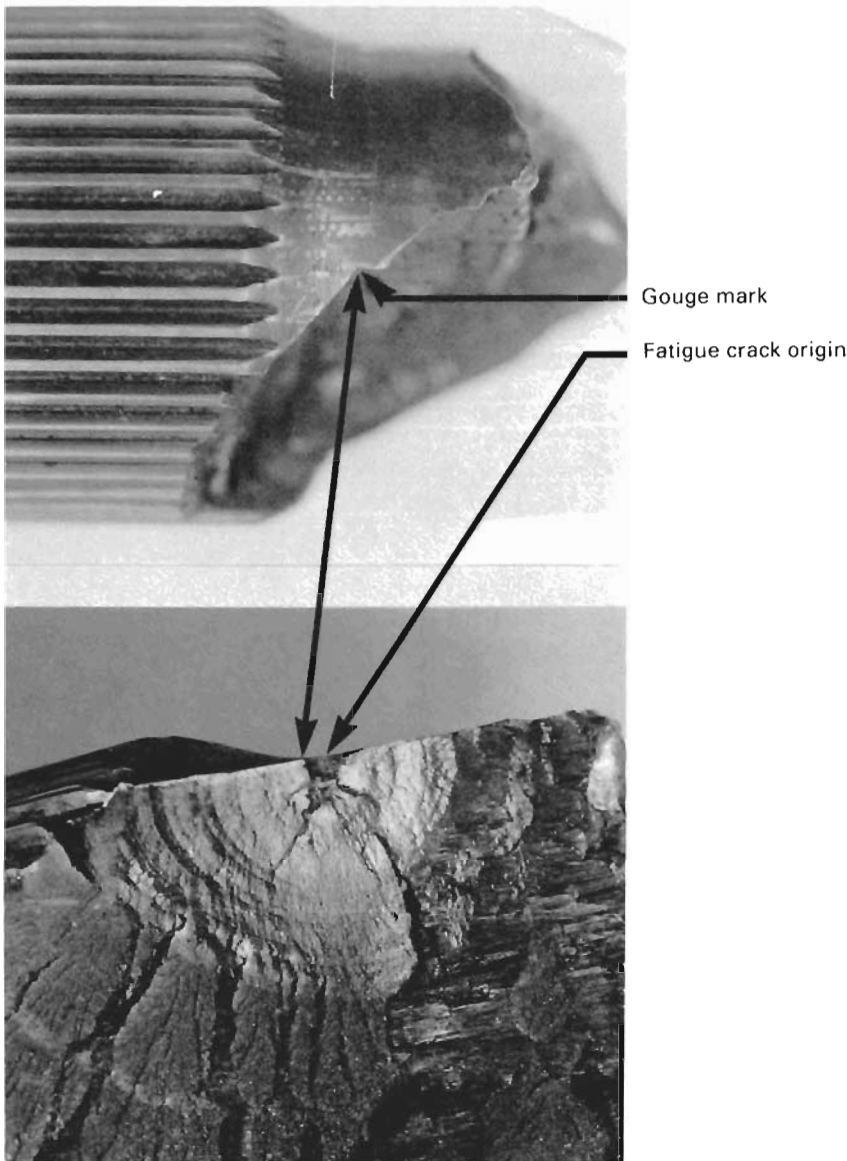
Fig. 6-1. Failure of this axle shaft resulted from torsional fatigue in the tensile plane, originating from one of several gouge marks observed around the shaft at the splined radius. The fatigue crack progressed for a large number of cycles before final fracture.

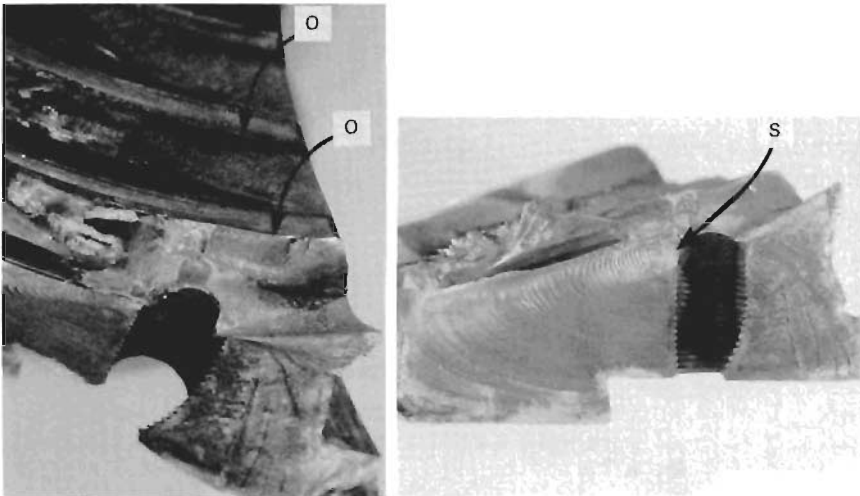
Progression is normally downward, toward the neutral point below the center of the tooth, and then upward to the opposite root. In this instance, a bolt hole was intercepted near its terminal end. A secondary fatigue (S) started at this intercept, and slowly continued both across and through the entire cross section of the gear until final separation occurred.

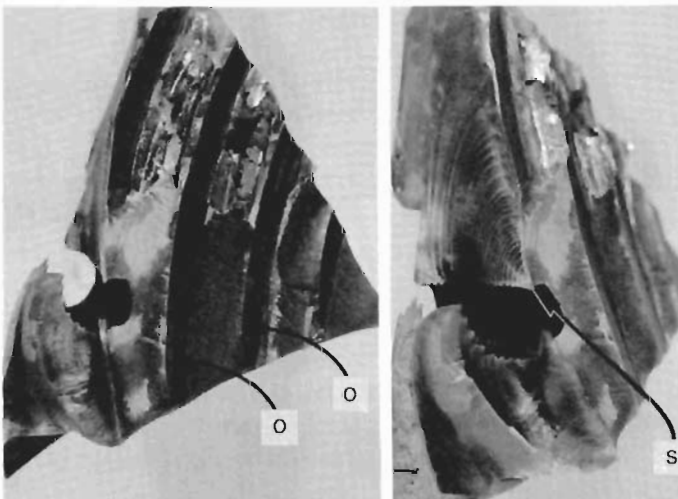
Fig. 6-2(b). Fracture "B" in the gear shown in Fig. 6-2(a). This fracture is an exact duplicate of fracture "A." See also Fig. 6-2(c).

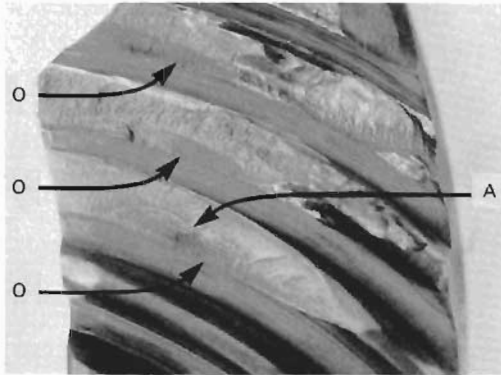
Fig. 6-2(c). Of the 15 teeth that failed by tooth bending fatigue, two fractures intersected a bolt hole (see Fig. 6-2a and 6-2b). Four other fractures touched the apex (A) of a bolt hole. Nine teeth failed by tooth bending fatigue completely away from a bolt hole. All 15 have an origin (O) in the same relative position.

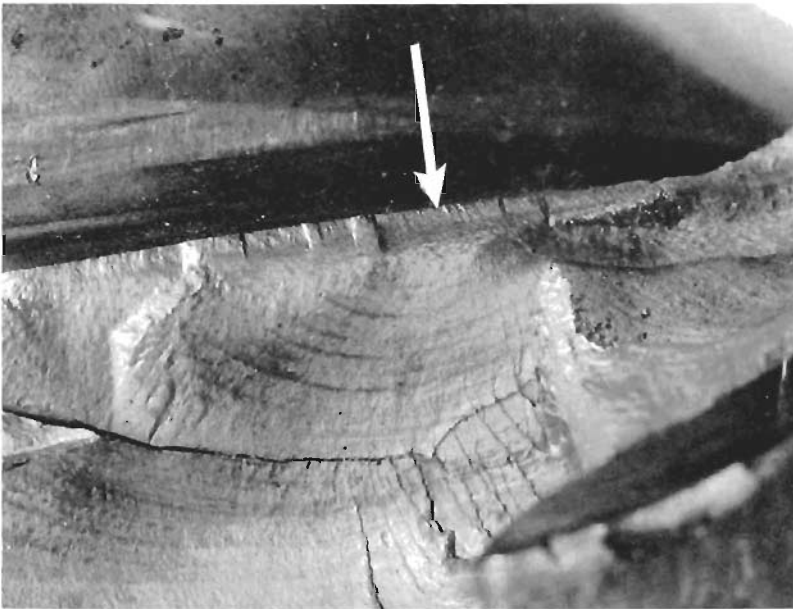
Fig. 6-3. Spiral bevel pinion tooth, 2 \times . Tooth bending fatigue with origin (arrow) at the root radius, exactly midway between the ends of the teeth.

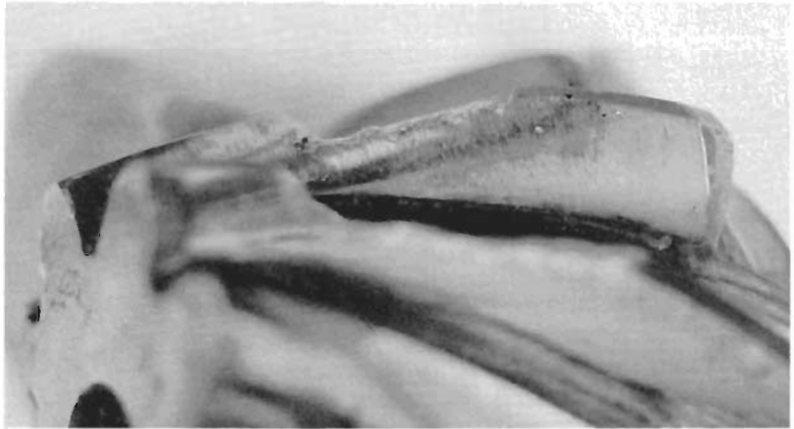
Fig. 6-6(a). Spiral bevel pinion, 0.9X. Seven of nine teeth failed by heavy rolling contact fatigue with the origin at a bias across the profile in a confined area.

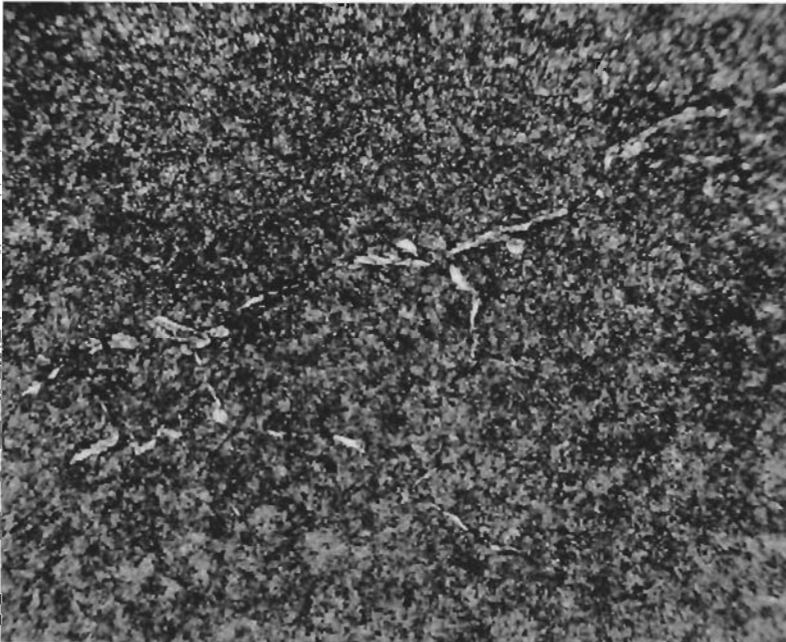
Fig. 6-6(b). Case microstructure (100 \times) of a high-compression area of one of the two intact teeth in the spiral bevel pinion shown in Fig. 6(a). Note the altered martensite in the subsurface shear plane. These “butterfly wings” extended from 0.010 to 0.035 in. below the surface.

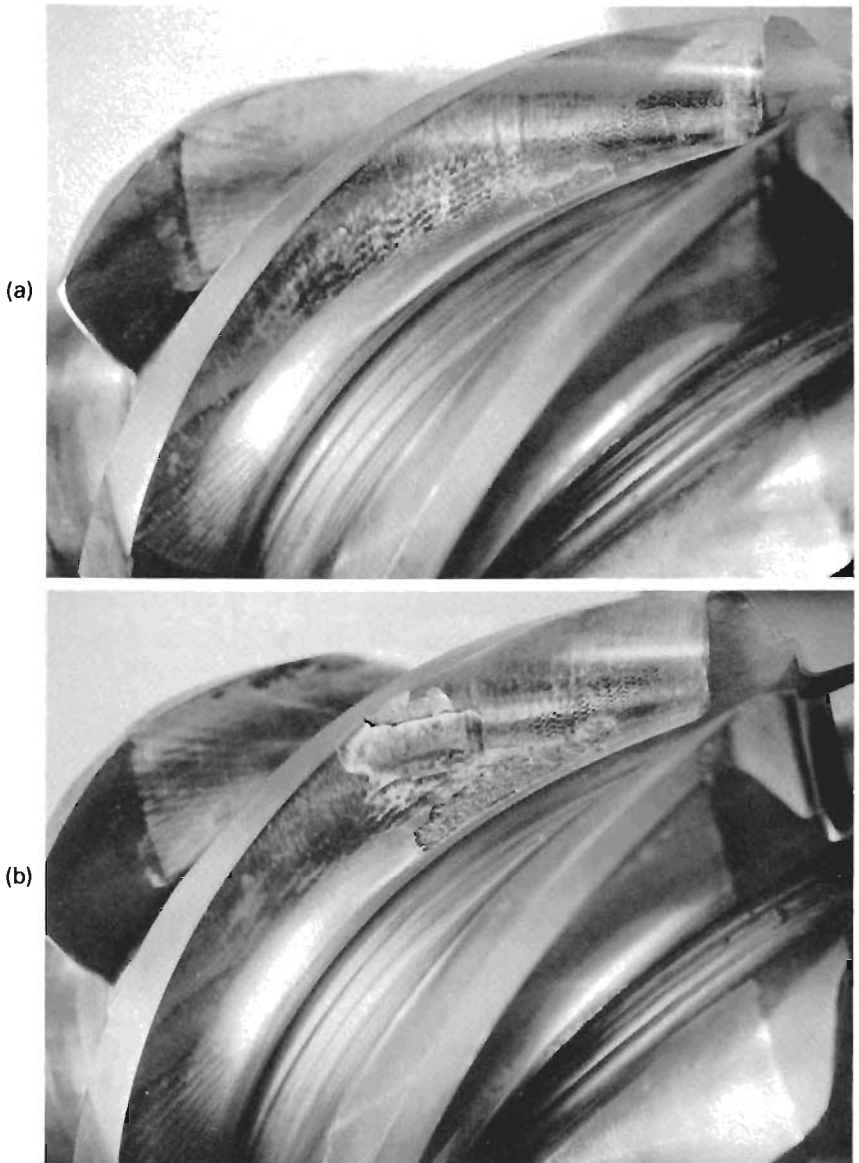
(a) A rippled surface for $\frac{3}{4}$ length of the tooth from the toe end. Pitting has originated low on the active profile, 2 in. from the toe end. (b) Pitting area has extended in both directions and has broadened. The central profile has an area of spalling that appears to be contiguous with the pitting. The microstructure indicates the two modes are occurring independently.

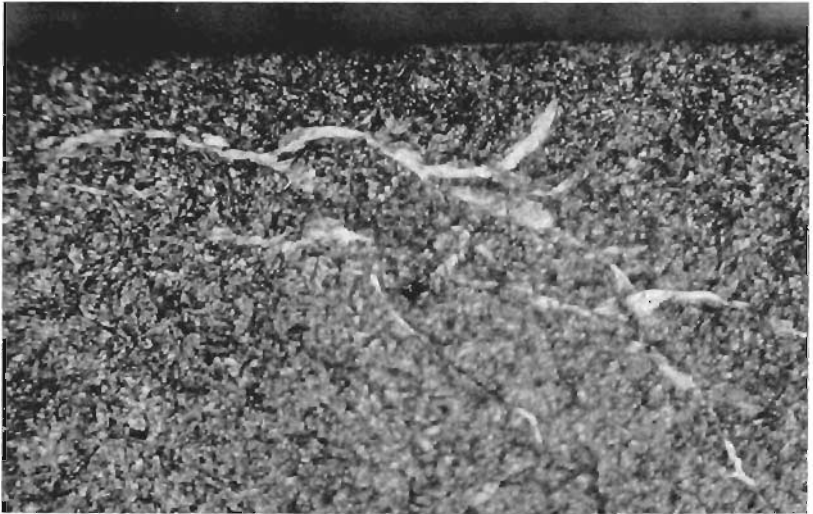
Note: the surface shows no catastrophic movement; the "butterfly wings" are generally parallel to the surface but extend 0.027 in. below the surface; and microstructure is very fine acicular martensite retaining less than 5% austenite.

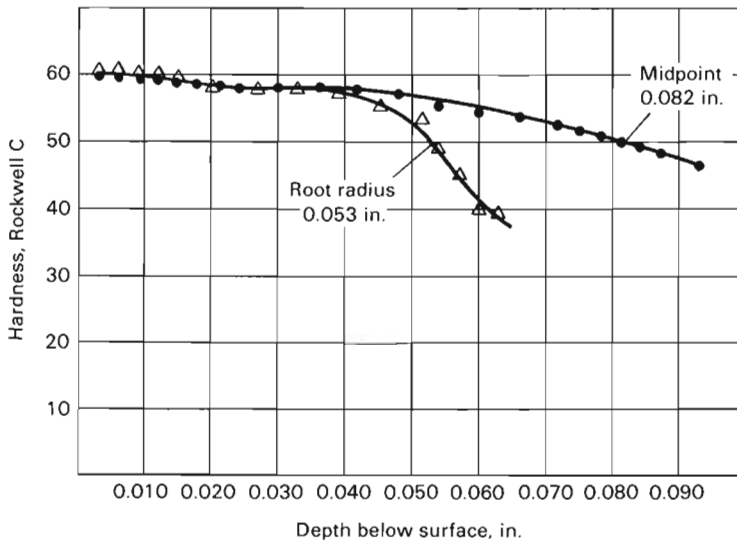
Fig. 6-7(d). Case hardness traverse of section used for Fig. 6-7(c) taken from tooth pictured in Fig. 6-7(b). Results are self-explanatory.

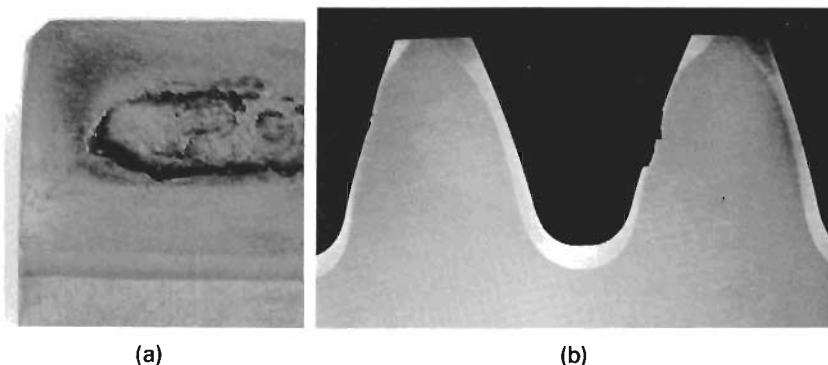
Fig. 6-8. Spur gear tooth, SAE 4147H, quenched and tempered to 311 HB, machined completely, induction hardened with a tooth space inductor by traversing one tooth space at a time. (a) Surface spalling along one tooth flank. (b) No hardened case on active profile of one side of the teeth.

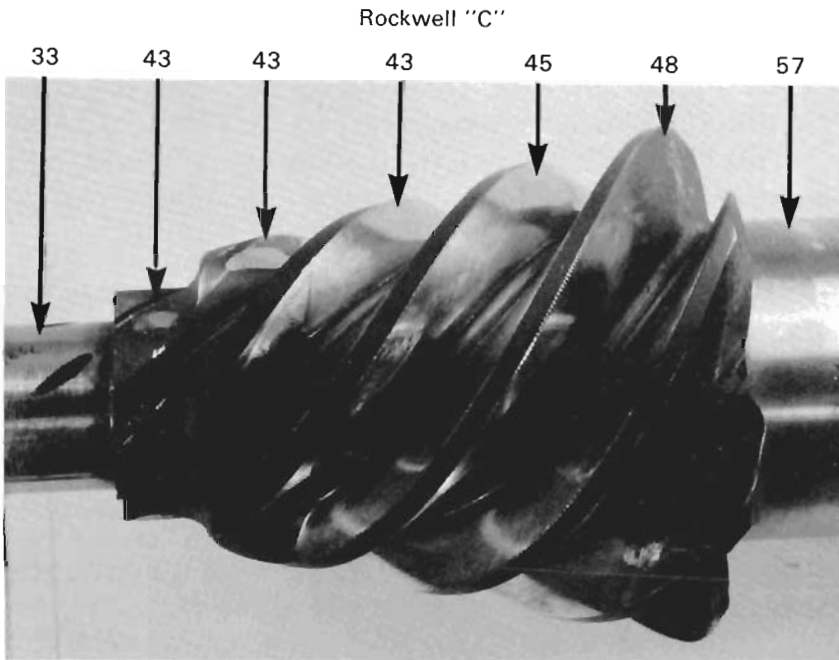
Fig. 6-9(a). Hypoid pinion, $\frac{3}{4}\times$. Mode of failure was a deep wear pattern toward the toe end. Note the surface hardness pattern that was the result of an improper quench.

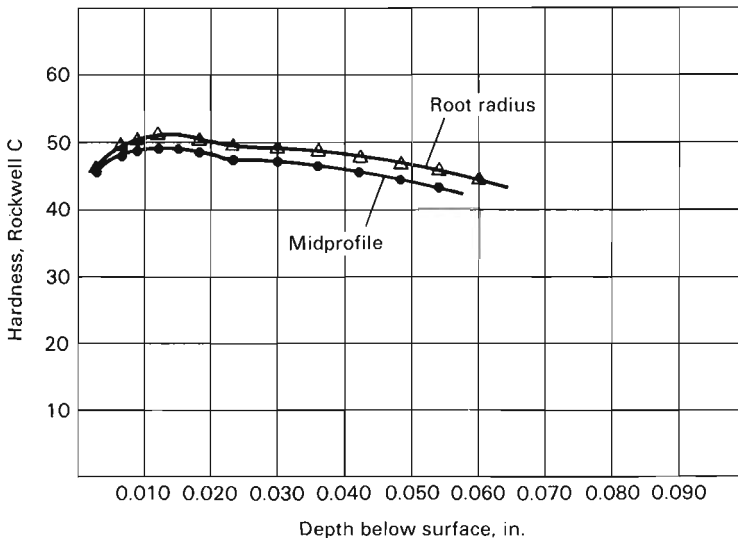
Fig. 6-9(b). Case hardness traverse used to diagnose the problem of the hypoid pinion shown in Fig. 6-9(a).

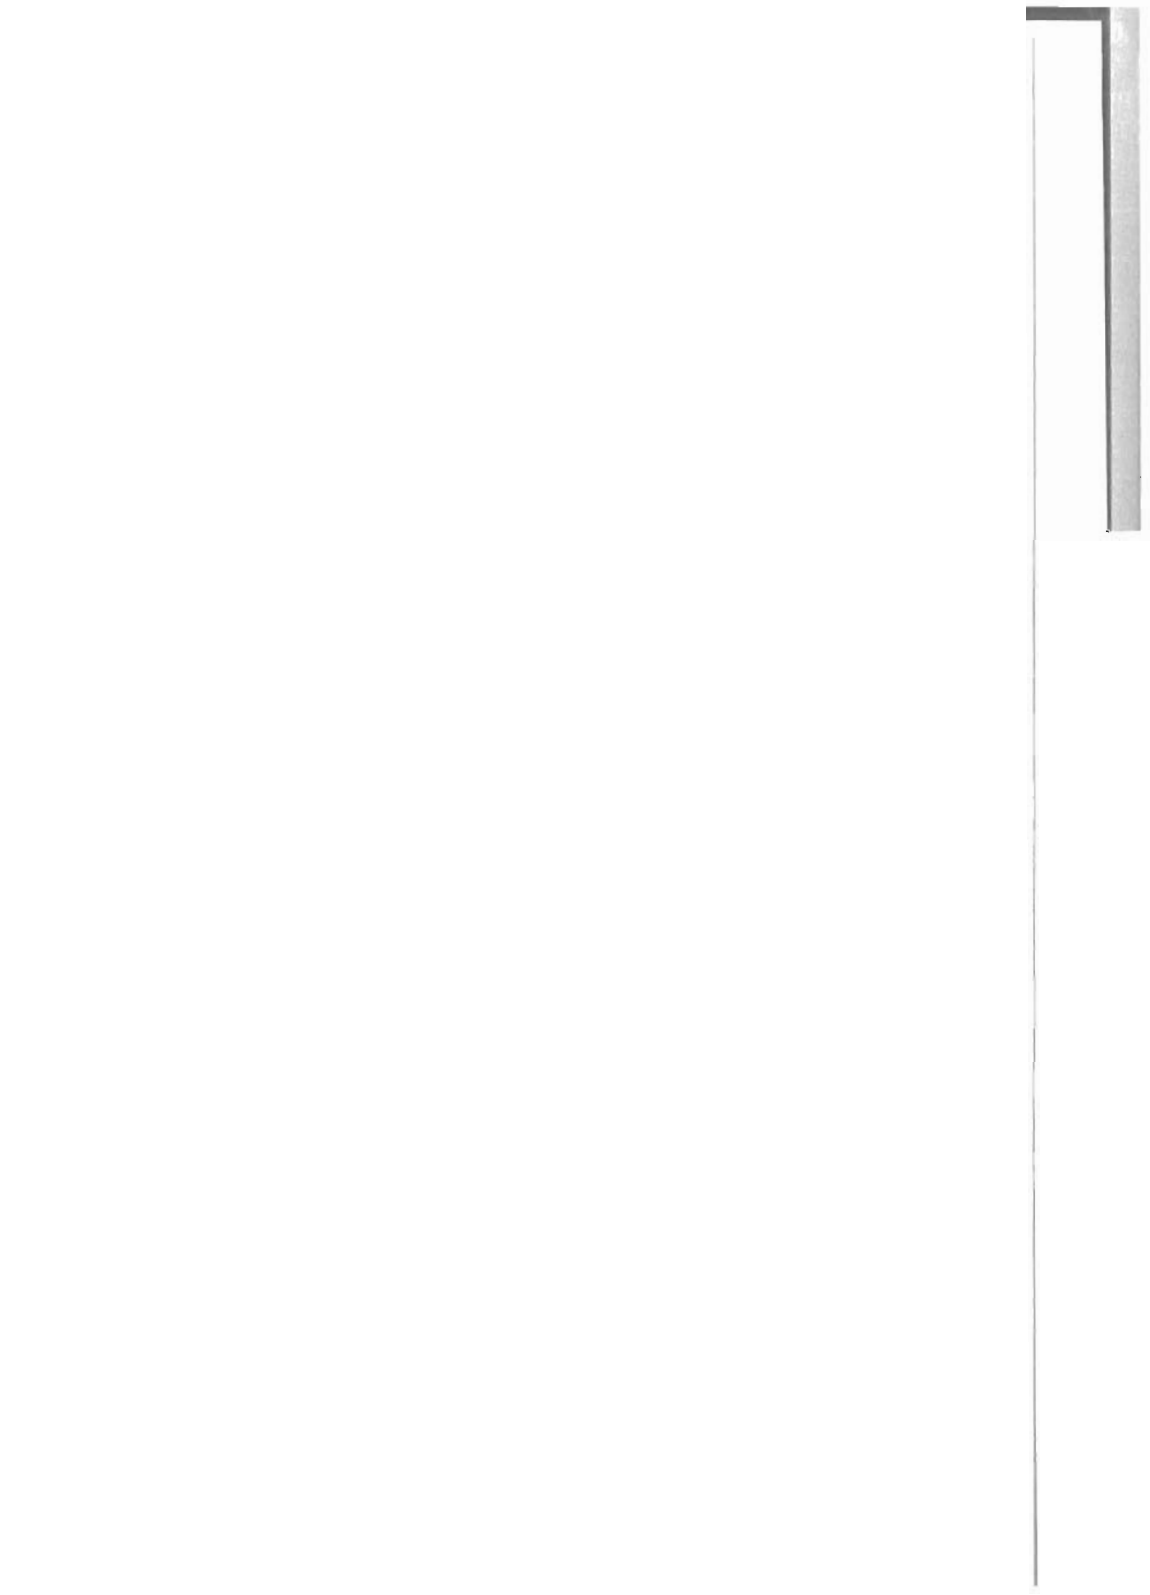
- Visual examination, 47-53
 use of low-power microscopes, 51
 use of observation and logic, 49-50
- Wear
 abrasive wear (F), 121-122
 adhesive wear (F), 123-125
